Vibration Instabilities on a Steam Turbine Generator Line

Depending on the resources available, gas as well as steam admission turbine plants are used for power conversion. During the start-up of such a generator line in Austria (Figure 1), considerably increased shaft vibrations were detected in the partial load range. As a result, the plant operator refused acceptance. The reason for the increase in vibrations was unknown, therefore, KÖTTER Consulting Engineers was commissioned to

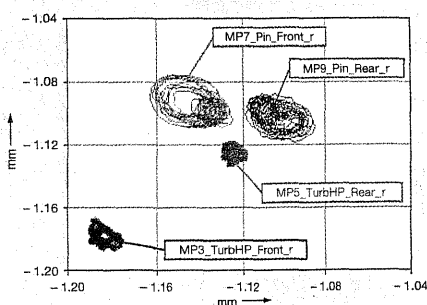
Figure 5. Orbit illustration of the shaft vibrations of turbine and pinion shaft at 0.3 MW (r_1 - axis horizontal, r_2 - axis vertical).

Figures 5 to 7 show the orbits of the fast-running shaft for a stationary load of 0.3, 2 and 4 MW.

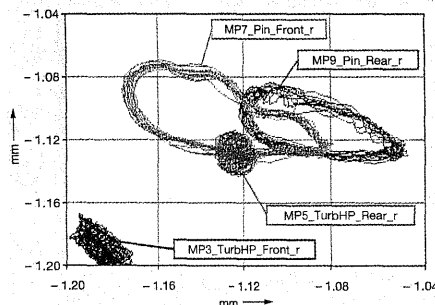
Figure 6. Orbit illustration of the shaft vibrations of turbine and pinion shaft at 2 MW (r_1 - axis horizontal, r_2 - axis vertical).

Considerably increased amplitudes are detectable particularly at the pinion shaft bearing in the partial load range of 2 MW (Figure 6). Higher shaft vibrations occur here also at the turbine shaft. However, judging by the size of the occurring disturbance amplitudes, no conclusions can be drawn as to the location of origin of the vibrations. The comparison of Figures 5 to 7 also shows how the shaft location, particularly at the pinion shaft bearing, changes considerably under minor load changes. The running direction, with which the orbits are passed through, is concurrent with the shaft direction of rotation. As from a load of approximately 4 MW, a very stable dynamic behaviour of the pinion shaft settles in again, with vibration levels below 20 $\mu\text{m p-p}$ (previously 95 $\mu\text{m p-p}$).

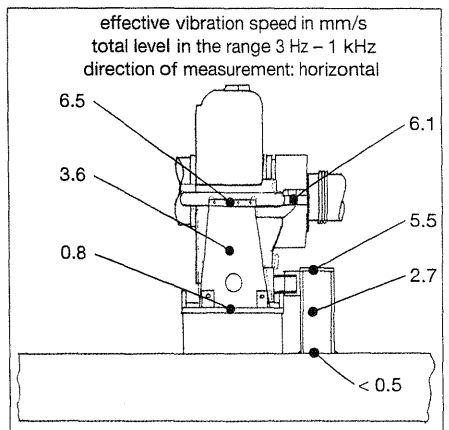
Figure 3. Measured effective vibration speeds in the zone of the turbine bearing on the low-pressure side, in the horizontal direction.

- Independent of the load range, increased bearing housing vibrations occurred locally confined at the outlet-side bearing of the low pressure part (DMP2_Turb-HP_Rear_h). The effective vibration speed of $v_{eff} = 7 \text{ mm/s}$ measured in the horizontal direction was primarily determined by a 25 Hz-component.

It was evident that the horizontal vibration level, proceeding from the foundation frame up to the level of the shaft line, had increased considerably (Figure 3). In order to record this amplification mechanism, impact tests were carried out at the bearing housing, with the plant shut down, for the purpose of determining the horizontal dynamic transmission behaviour. The impact test was carried out in the zone of the actual bearing housing (level of the shaft line) with a modal hammer tuned to a frequency range to be excited up to 300 Hz.

In the range of approximately 26 Hz, a natural frequency was clearly detected in the horizontal direction at the bearing housing of the low-pressure side turbine.

housing in the horizontal direction was proposed for the purpose of reducing the bearing housing vibration as mentioned above.

The recommended remedial measures were implemented immediately. The radial bearing clearance of the pinion shaft was reduced. After realisation, vibration measurements were performed by the manufacturer. The bearing housing vibrations were reduced to levels of maximum 1.8 mm/s eff (previously 7.1 mm/s eff). In addition, no instabilities whatsoever could be detected on the fast-running shaft. On the pinion shaft and in the objectionable lower load range, radial shaft vibrations with a maximum of only 14 µm p-p

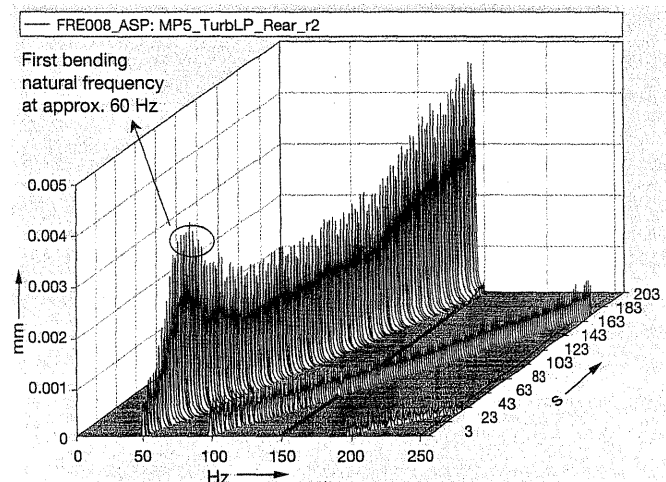
Figure 9. Waterfall diagram as amplitude spectrum of the radial shaft vibrations during capacity increase of the turbine shaft.

from approx. 3,000 to 9,000 1/min. This is illustrated in Figure 9 as a waterfall diagram of the radial turbine shaft vibrations.

It can be seen that, at approx. 60 Hz, a first vibration camber occurs which can be attributed to the first flexural natural frequency. This is confirmed based on the existing phase location of the shaft vibration. During the capacity-increase, however, the instability phenomena did not occur as shown in Figure 9. In fact the sub-synchronous vibrations were detected only after reaching the nominal speed and after the synchronisation of the generator, meaning, at the time of load.

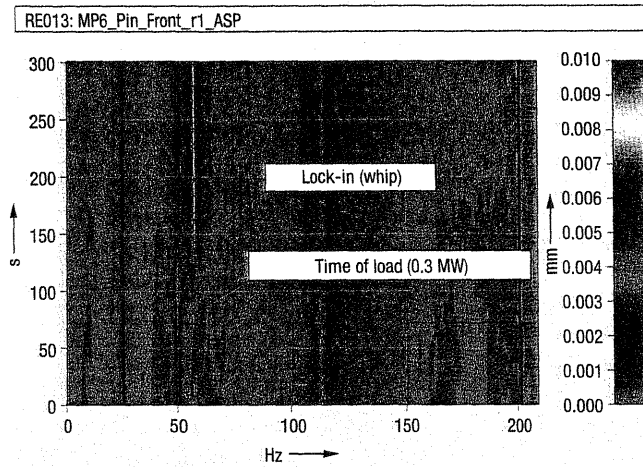
Figure 10. Colour map of the pinion shaft vibration at the beginning of load application.

It can be recognised in Figure 10 that, at the time of load and proceeding from a broadband spread vibration amplitude at approximately 115 Hz, amplitude and frequency fluctuations in the range of 50 Hz ($T = 90$ to 120 s) occur and then, as from the time $T = 125$ s, an amplitude at a fixed frequency of approximately 57 Hz settles in. It is noticeable that, at first, vibrations at approximately 0.6-times the rotating frequencies are observed which then, after load has been given up, diminish and increased vibrations settle in at approximately 0.3-times the rotating frequencies.

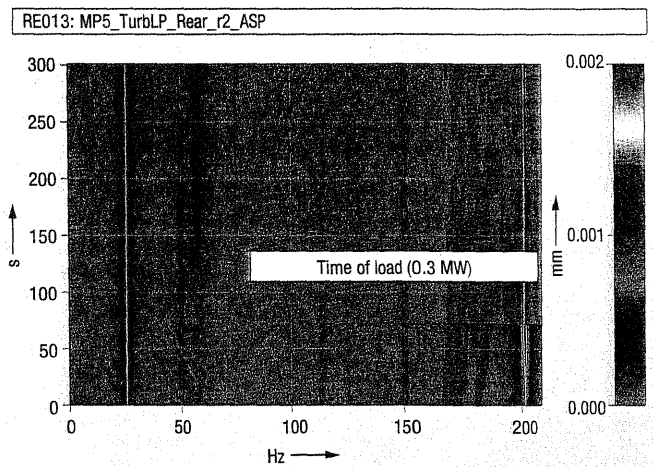
Figure 11. Colour map of the turbine shaft vibrations at the beginning of load.

Figure 11 shows this sequence at the turbine shaft with a slight delay. However, it is not possible to clarify exactly where the phenomenon first occurred.

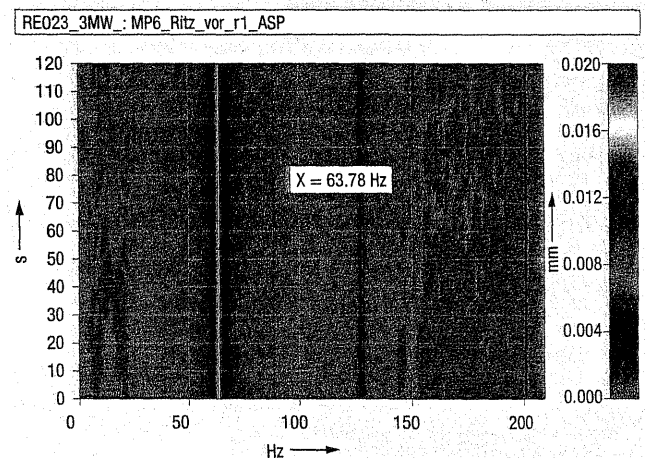
Figure 12. Colour map of the sub-synchronous vibration of the pinion shaft “locked-in” on the flexural natural frequency of the turbine shaft.

For the purpose of a further comparison, Figure 12 shows the load case with 3 MW (constant) as a colour map. It is obvious

that this is a “lock-in” of the determined phenomenon on the flexural natural frequency (oil whip). During the course of events, load-dependent fluctuations with regard to frequency are no longer recognisable.

The furthermore determined sub-synchronous frequency change from approximately 57 Hz at min-load to approximately 64 Hz at a load of 3 MW was attributed to the influence of the slightly changing overall bearing stiffness on the flexural natural frequency of the turbine shaft.

A modification of the pinion shaft journal bearing system was recommended as a remedial measure for the purpose of avoiding instability. In this case, influence can be effected by way of an alteration of the bearing geometry (bearing type, width ratio, clearance) and also by way of the bearing loading and/or the viscosity of the lubricant. In addition to this, a stiffening of the low-pressure side bearing
