Appearances are deceptive

MACHINE DYNAMICS

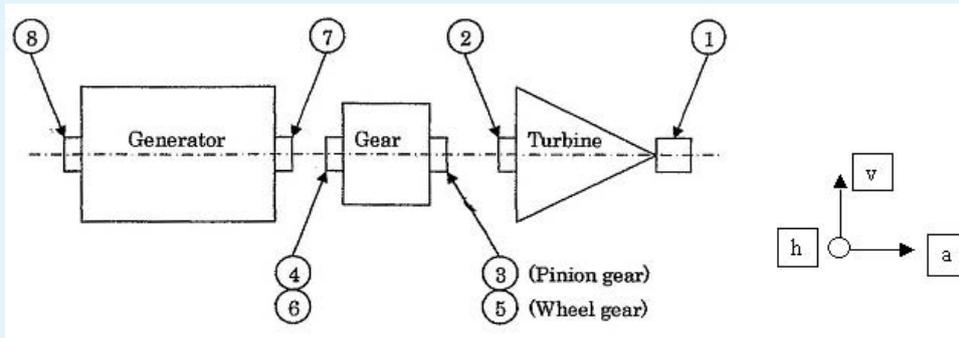
During the commissioning of the generator the staff observed increased vibrations, especially at the generator (figure 1). The vibration analysis, which was then carried out by the operator with a FFT-analyser, showed that increased vibrations especially occurred at the bearing shield of the generator in axial direction (figure 5, initial situation). A more detailed analysis revealed that the dominant frequency of the vibration corresponded to the double-rotational frequency of the generator (figure 2).

Location of the measuring points: MP_1a: measuring point 1 in axial direction / MP_1h: measuring point 1 in horizontal direction / MP_1v: measuring point 1 in vertical direction (all other measuring points analog)

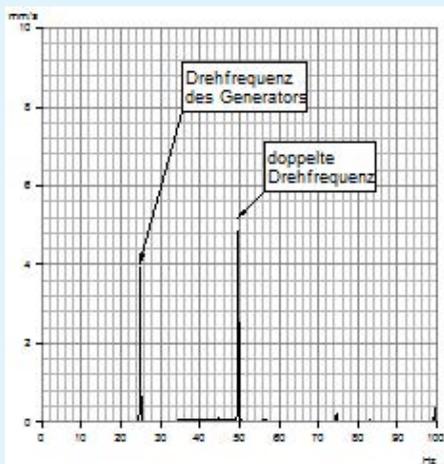
From relevant literature and experience it is known that the existence of the double-rotational frequency with significant amplitude in axial direction is an indication for an insufficient alignment of the machines. Therefore, the operator tried to improve the vibration situation by changing the alignment. As this was not successful, KCE was asked to analyse the cause on-site. A detailed investigation of the vibrations, recorded simultaneously at different measuring points during start-up and shutdown of the plant, showed that the bearing shield of the generator in axial direction had a natural frequency of approx. 45 Hz (figure 3).

FFT-analysis of the vibration velocity at the measuring point MP_7a in axial direction at a speed of $n = 1,490$ rpm

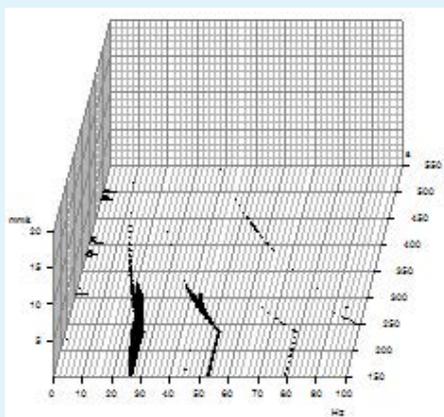
The FFT- analysis from figure 3 shows that at a speed of 1,590 rpm the double-rotational frequency at approx. 53 Hz has a smaller amplitude than the rotational frequency. With decreasing speed, the amplitude of the double-rotational frequency increases and reaches a maximum at $t = 270$ s resp. at a speed of 1,340 rpm.

Waterfall display of the FFT-analysis of the vibration velocity at the measuring point MP_7a, shutdown of the system at $n = 1,590$ rpm

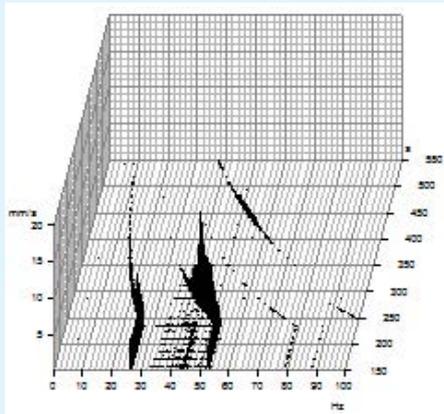
However, the vibrations in vertical direction did not show any dominance. At the double-rotational frequency (figure 4), the vibration predominant amplitude lay on the single-rotational frequency of the generator, the predominant vibration amplitude lay always at the single-rotational frequency of the generator.

Waterfall display of the FFT-analysis of the vibration velocity at measuring point MP_7v, shutdown of the system at $n = 1,590$ rpm

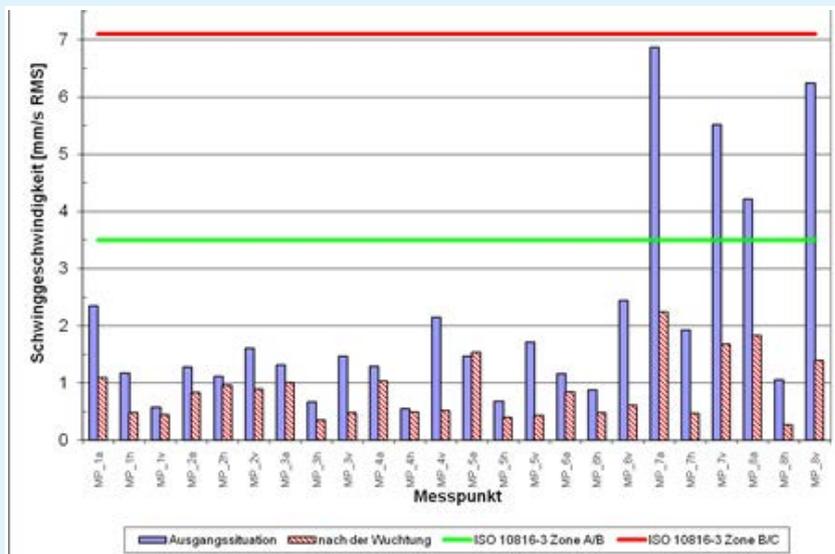
As one can see, the guideline values of DIN ISO 10816 - part 3, zone A, were met after the operational balancing so that the system could be used without restrictions in long-term operation. With the KCE experts still on-site, the system was accepted by the customer. The case study described is a good example that increased vibrations can also occur in an untypical form of appearance, depending on the individual situation. The example makes clear how important it is for the analysis of the situation on-site to consider all appearances and possible causes. Thus, costly delays during the commissioning process can be avoided.

Effective vibration velocities measured in the initial situation and after operational balancing

A change in the generator's alignment did not lead to a significant improvement of the vibration situation. It was decided to install a test mass at the rotor of the generator to determine the influence of the vibrations. This measure showed that axial vibrations at the generator were mainly excited by a residual imbalance in the rotor of the generator and not – as originally assumed – by an incorrect alignment. After test runs, an improvement of the vibration situation (shown in figure 5) was reached.
