## Commissioning problems at a turbo compressor in Egypt

MACHINE DYNAMICS

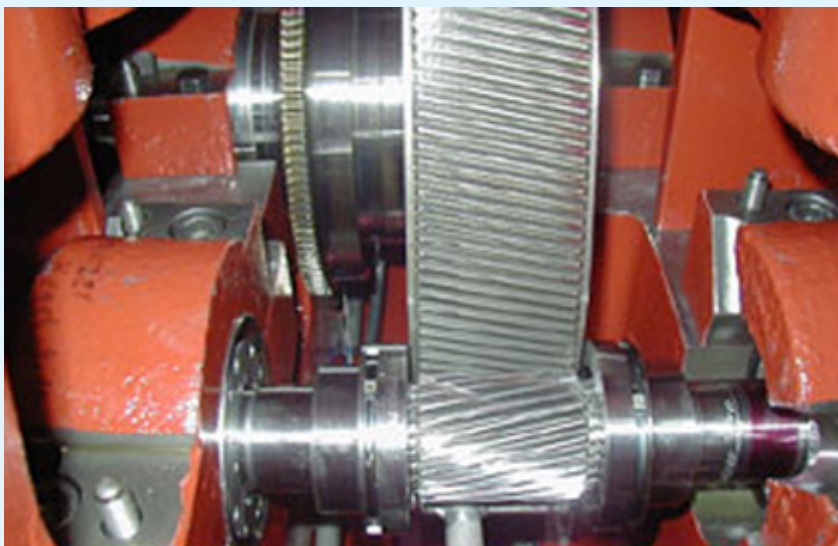
Pinion shaft and wheel shaft of the turbo compressor

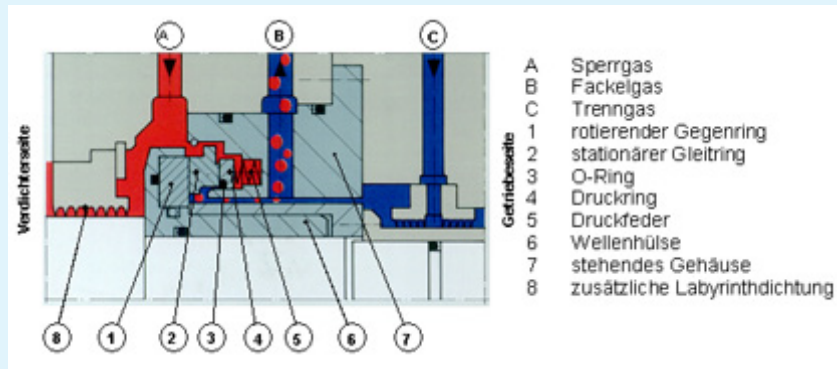
In a new chemical factory near Alexandria, Egypt the commissioning of a plant section was delayed. Repeatedly a defective mechanical seal at the pinion shaft of a turbo compressor caused the problem. This sealing system consisted of a stationary, spring-loaded seal and of a rotary counter ring (figure 2). The sealing face of these two rings slid contact-free. In the outer area of the rotary counter ring the gas to be sealed was fed and compressed due to the installed grooves.

Mechanical seal system

Furthermore, the installed bidirectional mechanical seal was replaced by an unidirectional seal, insensitive to vibrations, which was already previously used at the compressor. After implementation of these measures, the compressor was put in operation without problems and was running without any interference.

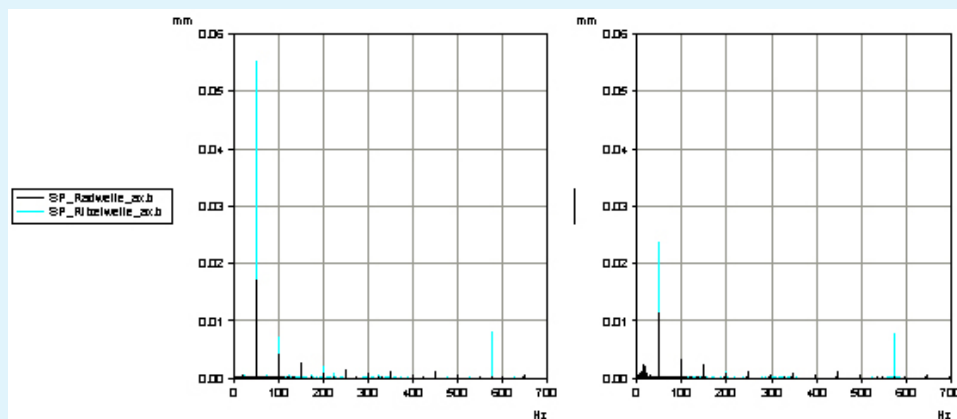
The measurement was carried out with nitrogen in closed-loop mode. As an important result, an increased level of the axial shaft vibration of the pinion shaft was detected. The guideline value for the axial vibration of the seal stated by the manufacturer was exceeded so that an overload of the seal could be reached.

An imbalance in the slow running drive train was the cause for these increased axial vibrations of the pinion shaft and probably also for the repeated damage of the mechanical seal. After precise dynamic balancing at the coupling between the gear and the electric motor, the housing vibrations could be reduced decisively. At the same time, the axial vibrations of the pinion shaft and therefore the mechanical seal decreased by more than 50 % (figure 3).

Axial pinion shaft vibrations before and after the balancing
