Coupling damage at a compressor of a LPG-tanker

MACHINE DYNAMICS

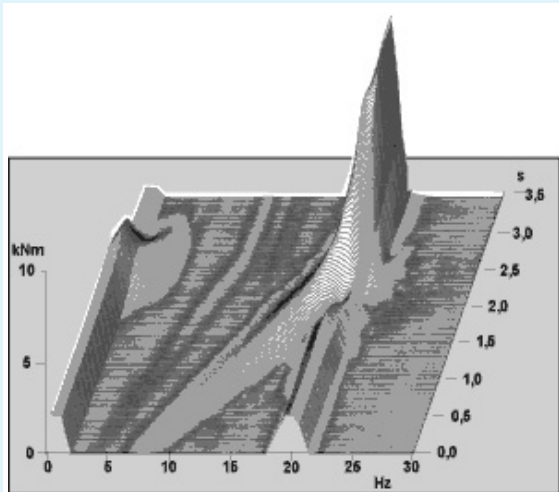
This measurement of the torque (figure 3) showed a significant torsional vibration in the double torque frequency of the compressor, overlaying the rated torque, which led to harmful alternating loads of the coupling. An analysis of the natural torsional frequencies during standstill of the compressor revealed that the first natural torsional frequency of the drive shaft lay very close to the frequency of the double operating speed of the compressor. The excitation did not occur directly through the motor but mediated via the compressor side. So, the mechanism of action was detected and in a second step target-oriented measures were proposed and designed.

Time-amplitude spectrum of the torque process during start-up

Due to the pros and cons of the proposed measures and the costs of their implementation, finally the diameter of the intermediate shaft was enlarged so that the natural torsional frequency was shifted out of the critical band of excitation. Since realisation of this measure, no coupling damages appeared at the "Wilhelm Schulte" and two other ships with 10 identical compressors.
