Damages at a compensator in a flue gas duct of a desulfurization plant

Analysis of damages by means of a 3D-flow simulation (CFD)

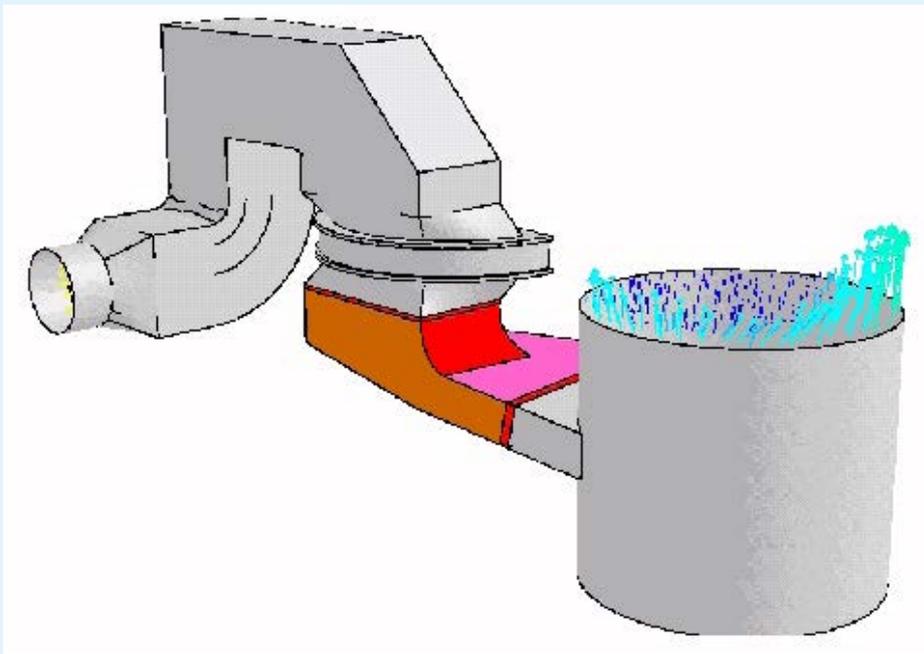
Overview of the calculated duct section near the regenerative preheater.

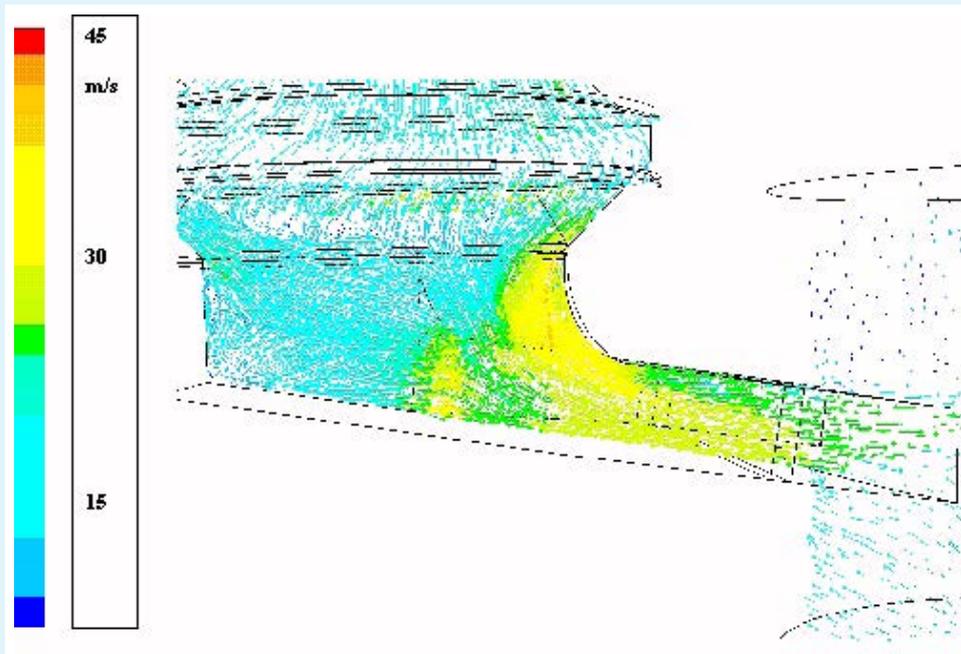
To analyse the problem, a 3D-flow simulation was carried out. It illustrated that significant overspeeds occurred near the compensator at the downstream side (level 1: area of the crack). This resulted in falling static pressures (fig. 1 and 2). At the same time, the flow at the compensator at the side of the crack formation detached due to a sharp-edged deflection.

Velocity vectors near the regenerative preheater.

By means of a CFD-calculation a periodical change between over- and underpressure within the duct near the compensator could be analysed as possible cause for the damages. The bellow dented in and out permanently so that it finally cracked. To eliminate this cause, the flow guidance had to be optimised in this area.
