Minus 170° C ... and it works!

MACHINE DYNAMICS

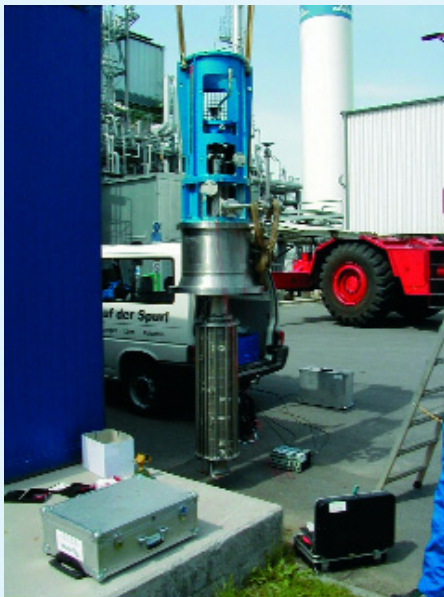
Last preparations of the sensors at the centrifugal pump before re-commissioning

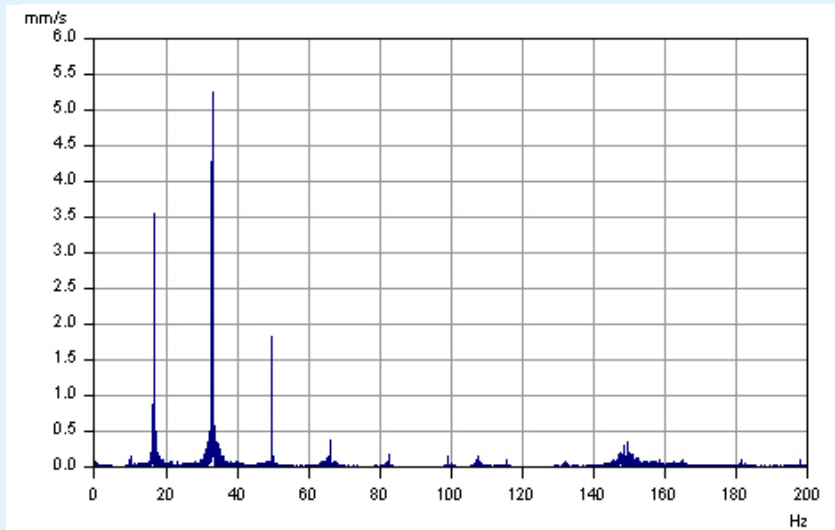
During re-commissioning the measured vibrations showed a normal vibration behavior after start. At that point of time, the quality of the measurement signals was comparable with that at the test-bench. After approx. 15 hours of operation, together with the beginning of a loss in pump power - and therewith a new damage – a subsynchronous rotational frequency component could be determined in the vibration signals. This component mainly appeared at the measuring level at the inducer of the hydraulic unit. When the broadband vibration level increased, the first mechanical bending natural frequency of the hydraulic unit was excited as well. In total, the guideline values were significantly exceeded at the measuring points at the hydraulic unit within the pump can. However, the vibration level kept the guideline values at the measuring points outside the pump can.

The measured values confirmed that primarily an arising rotor instability was responsible for the damage. A decentering effect of the forces in the bearing and/or sealing gap led to a destabilisation of the rotor and therefore to vibrations which appeared as subsynchronous rotational components in the signals. As reduction measures KCE recommended the following modifications:

Frequency spectrum of vibration velocity after approx. 15 hours of operation – measuring position at the entrance of the hydraulic unit

- a) Increasing the load capacity of the radial bearings
- b) Reducing the peripheral speed of the fluid within the sealing gap
- c) Reviewing the design of the inducer, possibly working without inducer

When the manufacturer reviewed the centrifugal pump, especially the load capacity of the slide bearings at the beginning of the hydraulic unit was improved and for this application the centrifugal pump could work without inducer.

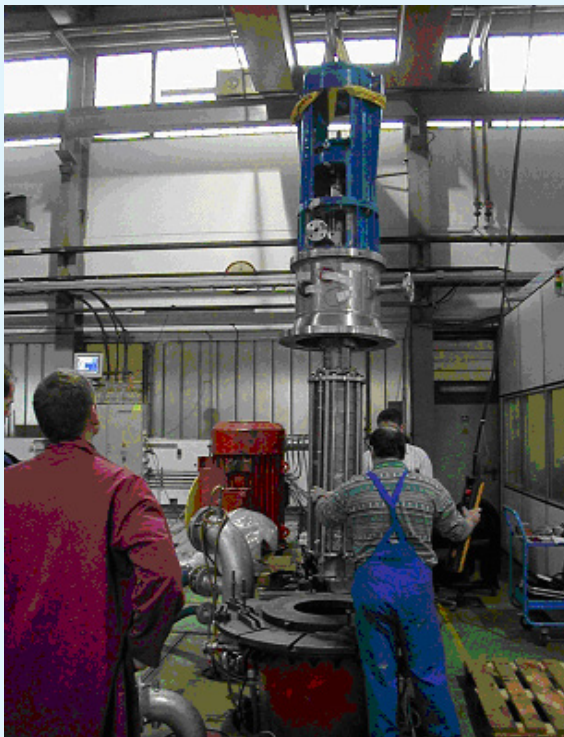
To estimate the basic vibration situation during operation of the centrifugal pumps and to determine a reference state, measurements at a test-bench of the manufacturer during operation with water were carried out in a second step. Here, also the relevant structural-mechanical natural frequencies of the centrifugal pump were determined.

Installation of the centrifugal pump for a test run at the test-bench
