TROUBLE SHOOTING BY A COMPREHENSIVE VIBRATION STUDY DURING THE START-UP OF A TURBO COMPRESSOR

Dr.-Ing. Johann Lenz

KÖTTER Consulting Engineers KG, Rheine, Germany
lenz@koetter-consulting.com

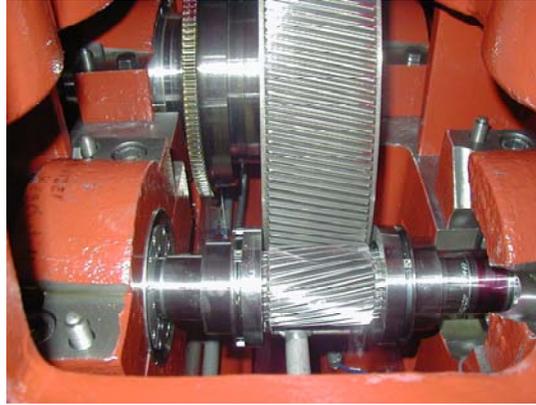
The start-up of a plant section in a newly established chemical factory was delayed for several months. The reason was a repeated case of a defective mechanical seal system on the pinion shaft of a gear type centrifugal compressor (fig. 1).

Figure 1: View on the pinion shaft (foreground) and bull gear of a gear type centrifugal compressor.

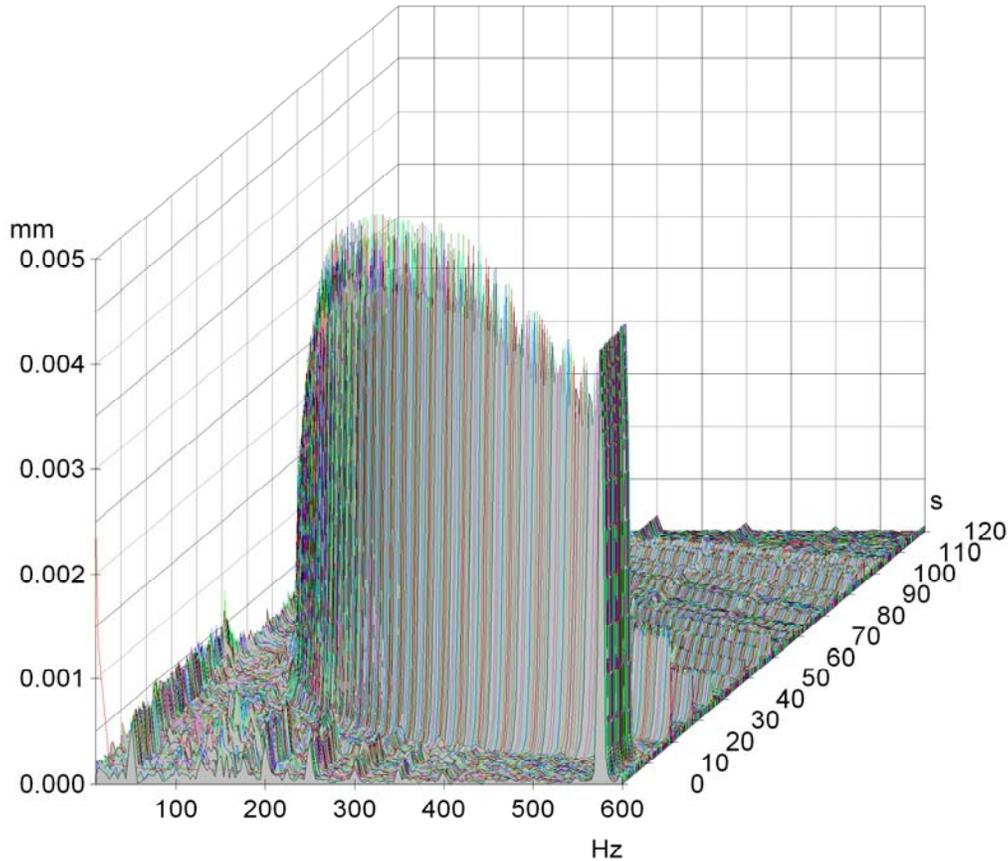
Figure 6: Waterfall chart of the amplitude spectra of the radial shaft vibrations on the non-drive side of the pinion shaft (measuring point NDS1_Rw_r) during coast down (operating speed approx. 570 Hz) of the compressor.

The amplitude of the shaft vibration did not indicate any conspicuously resonant increased values, neither during capacity increase nor during coast down of the compressor (1. bending frequency was in the range of 200 Hz, fig. 6). In the stationary operation the allowable limit values of the radial shaft vibration were also not exceeded.

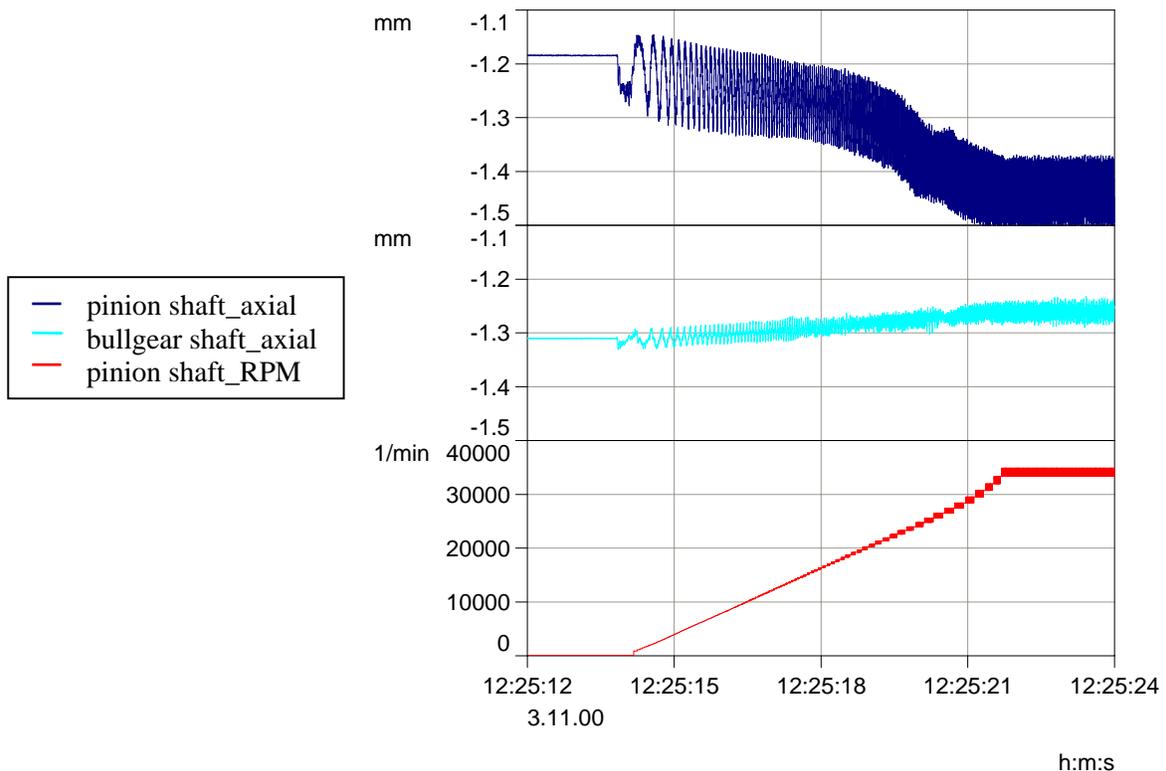
With regard to the first point, the axial displacement and vibration of the pinion and wheel shafts were recorded during the start phase of the compressor (fig. 7). The pinion shaft was displaced by approx. 0.3 mm and the bull gear shaft by approx. 0.05 mm in the direction of the compressor side (refer to the measuring point location in fig. 4). A comparison with the pre-specified clearance of the pressure comb (0.25 mm) as well as of the axial bearing (0.1 mm) confirmed the allowance of the displacements determined in operation.

Figure 7: Axial displacement of the pinion and bull gear shaft during capacity increase of the compressor.

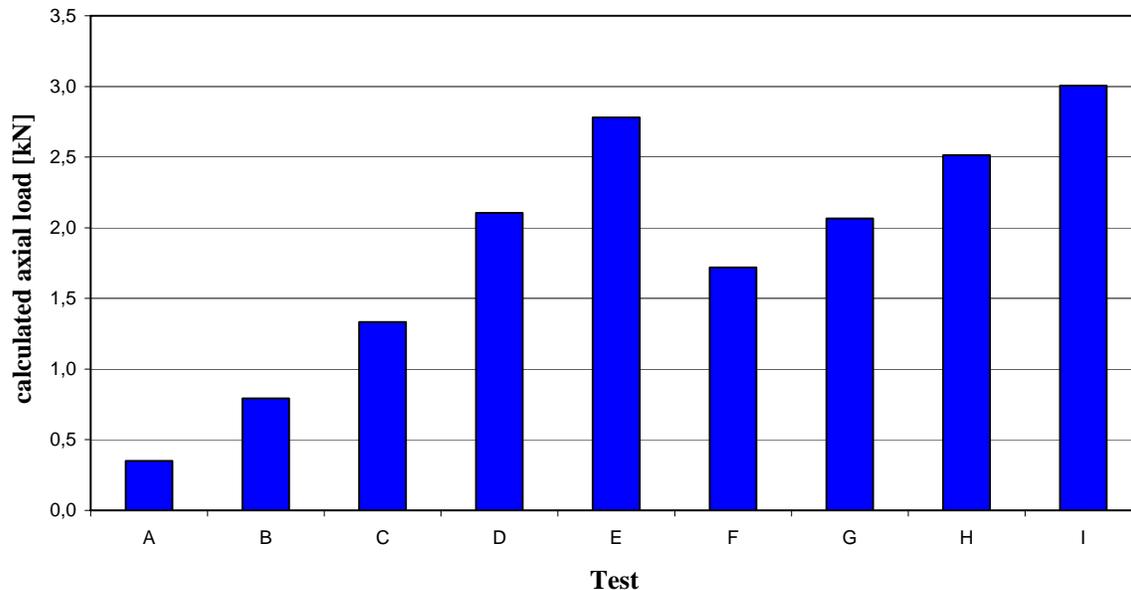
Figure 8: The axial load of the pinion shaft calculated from the measured pressure for the nine different operating points.

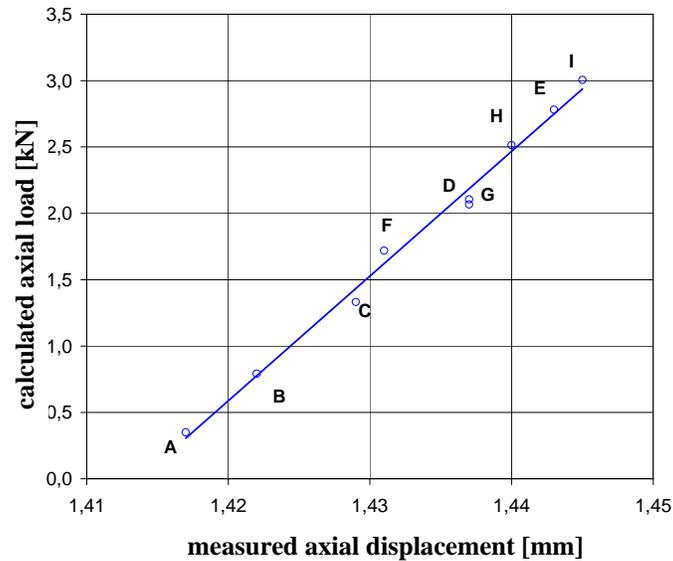
Figure 9: Comparison of the calculated axial loads at the pinion shaft and measured axial displacement for the nine different operating points.

Proceeding from the operating point A and by means of the straight line entered in the diagram, there is a very good linear dependence between the measured axial displacement and the calculated axial load so that an axial instability of the pinion shaft in the stationary condition can be ruled out.

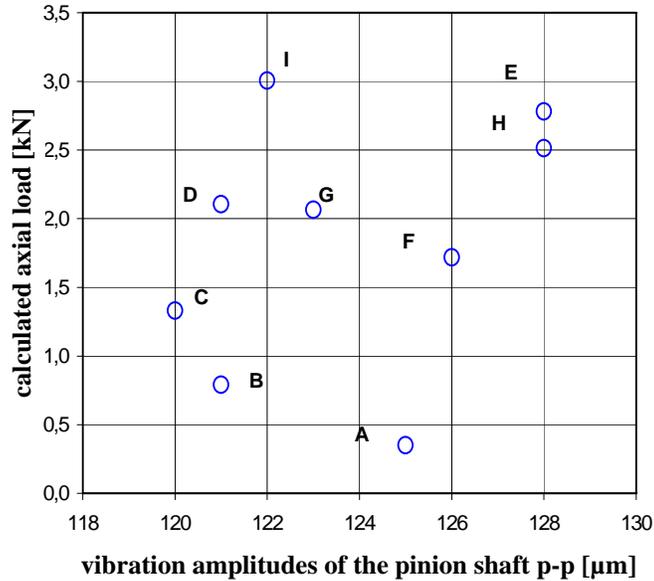
Figure 10 shows the axial pinion shaft vibrations as measured at the different operating points. No functional correlation to the acting forces at the pinion shaft can be determined here.

Figure 10: Comparison of measured axial vibrations and calculated axial forces at the pinion shaft for the different nine operating points.

However, in addition to these facts which have remained inconspicuous up to now, an increased level of the axial shaft vibrations of the pinion shaft (fig. 10) was detected. The measured spectrum, as shown in figure 11, shows for the axial vibration of the pinion shaft an amplitude of approx. 55 μm for the rotation frequency of the bull gear shaft of 49.5 Hz.

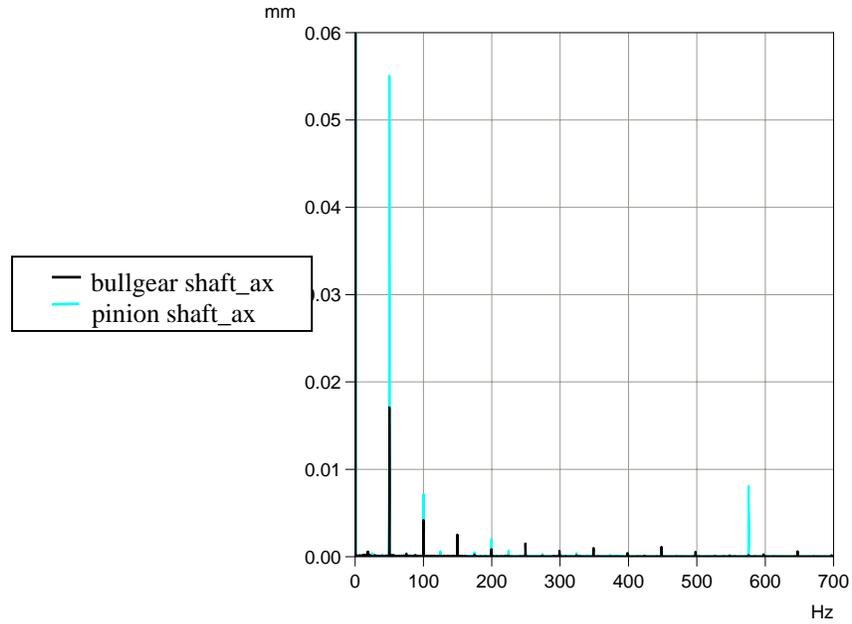
The limit value specified by the manufacturer for the axial vibration of the seal was exceeded so that a non-allowable loading of the seal can certainly occur here in this case. A remarkable fact was that the axial vibration of the driven wheel shaft at this rotation frequency only had an amplitude of approx. 18 μm (fig. 11).

Figure 11: Amplitude spectra of the measured axial vibrations of pinion shaft and bull gear shaft.

The cause of the increased axial vibrations of the pinion shaft and presumably also for the occurring damage to the mechanical contact seal was unbalance in the slow-running drive line. The casing vibrations were decisively reduced by precise dynamic balancing at the coupling between the gear and the engine. In parallel to this, the axial vibrations of the pinion shaft and of the mechanical contact seal also were reduced by more than half. In this type of gear configuration, it was evident that the axial vibrations of the high-speed pinion shaft react very sensitively to an unbalance of the slow-running bull gear shaft.

Moreover, the bidirectional mechanical contact seal was replaced by a more vibration-insensitive unidirectional seal that had been once originally deployed in the compressor. Following implementation of the precautionary measures, the compressor went into operation without any problems and has been running for more than 20,000 hours without any further disturbances.

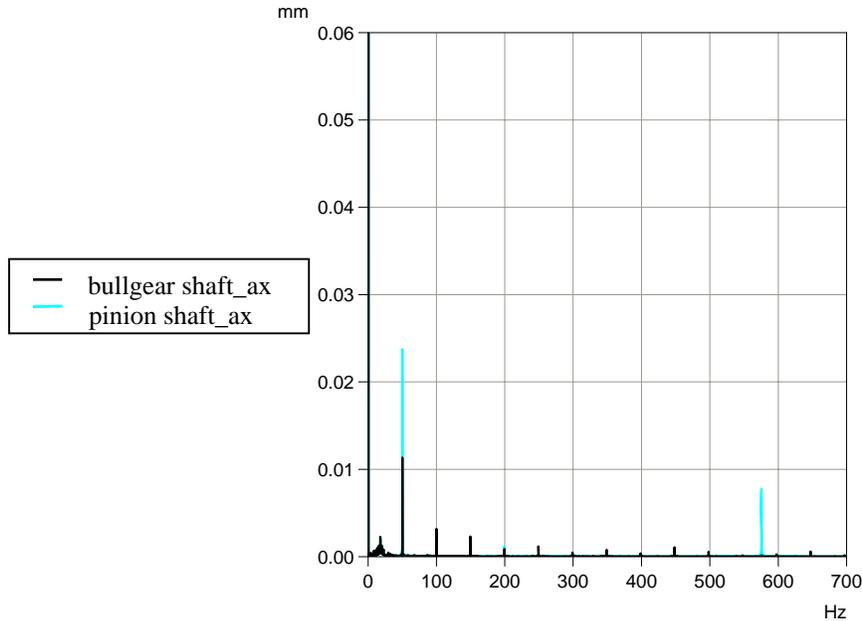
Subsequently, the task was to analyse as to how this axial vibration is amplified from the bull gear shaft to the pinion shaft. A simultaneous measurement of the horizontal casing vibration offset at 90° to the shaft location showed an increased vibration velocity of $v_{\text{eff}} = 5.6 \text{ mm/s}$ with a distinctive amplitude of 7 mm/s , likewise in the rotation frequency of the bull gear shaft. The concentricity accuracy of the slow-running bull gear shaft had been inspected several times during the introductory phase. For this reason, the bull gear shaft was balanced at the coupling flange. In this way, it was possible to reduce the horizontal case vibration to an effective value of 1.2 mm/s . At the same time and in this way, the increased axial vibration of the pinion shaft was diminished to an amplitude of approx. $23 \mu\text{m}$ (fig. 12).

Figure 12: Amplitude spectra of the measured axial vibrations of pinion shaft and bull gear shaft after balancing.
