MACHINE DYNAMICS

## Vibration reduction on cruise liners

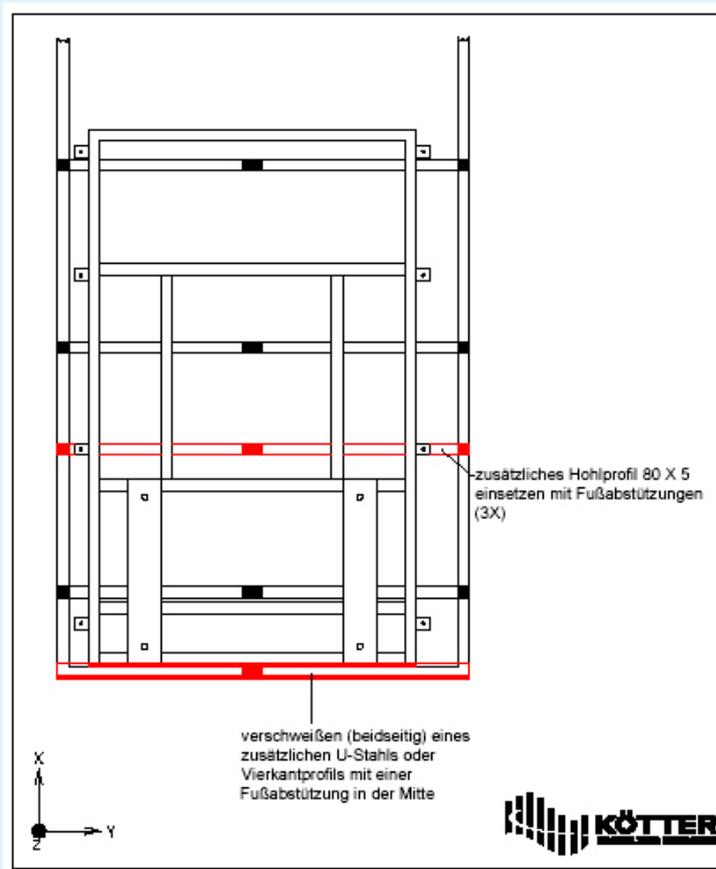
- excessive vibrations, mainly on the motor in vertical direction
- a tilting movement in the rotary frequency appeared on the direct axis of the motor
- During the warm-up period the amplitude of the vibrations multiplied by 2.5.

On the one hand, these excessive vibrations were caused by a vibration excitation due to the imbalance of the motor, increased by an additional thermal imbalance. On the other hand, an insufficient stiffness of the steel construction of the motor fastening was detected.

Solution: Stabilising the skid frame

To reduce the vibrations, an additional U-profile and support structure to stiffen the steel construction were implemented. The customer's control measurement approved the success of these actions. Vertical vibrations were reduced by a factor of 4 so that an additional balancing of the motor under load was not necessary.
