Successful vibration analysis on a 200 MW pump turbine in Luxembourg

Dr.-Ing. Patrick Tetenborg, Dr.-Ing. Johann Lenz, Dipl.-Ing. Gilles Nosbusch

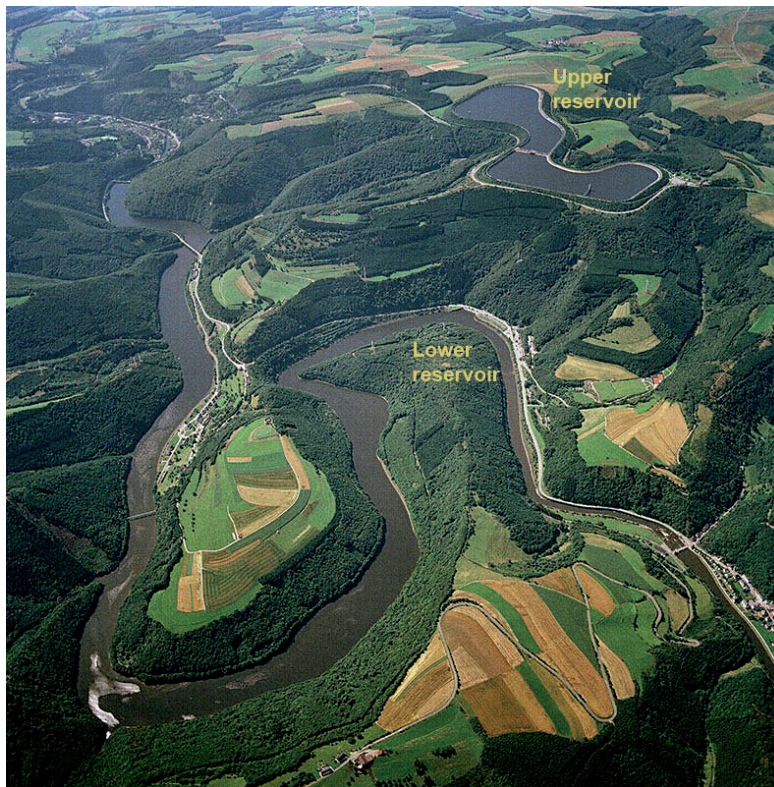
Fig. 1: Aerial photo of the separate upper and lower reservoirs along with the dammed course of the river (Our) in Vianden (Luxembourg).

The Vianden pumped-storage power plant in Luxembourg began operating at the end of the fifties and has since been expanded in various stages of construction. It is used to store excess energy – such as wind energy – and also to cover demand peaks. At times when consumption is low, for example at night, the excess energy from the base load power plants is used to pump water from the lower to the upper reservoir (storage). When the demand for electricity increases, the stored water flows through turbines back into the lower reservoir (see Figure 1).

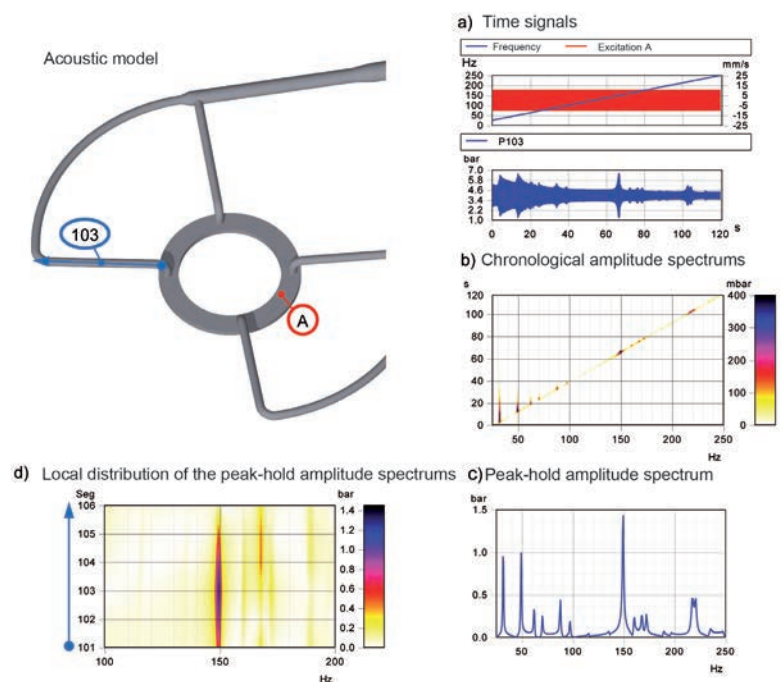
Figure 6 presents an excerpt of the modelled turbine cover pressure relief pipe and a one-dimensional illustration of the circular ring of the lateral impeller chamber. The investigated excitation positions and the positions of nodes relevant for the results are shown as well. A schematic of the evaluation is also presented. The simulations were performed in the time domain. The acoustic model was continuously excited using a frequency

Fig. 5: Exemplary illustration of the calculation results: Pressure fluctuations at node 103 as time signal, as colour chart illustration with chronological amplitude spectrums, as peak-hold amplitude spectrum of the individual spectrums, and as local distribution of the peak-hold amplitude spectrum in a colour chart.

In a first calculation step, the model was used to determine the acoustic transmission behaviour in the pipe as the actual situation. For this purpose, various exciter positions (here as an example: A) were used to induce pressure fluctuations in the lateral impeller chamber by specifying a frequency sweep of 25 to 250 Hz with a constant sound particle velocity amplitude. The system's acoustic transmission behaviour leads to different local distributions of the fluctuations depending on the excitation frequency and position. An acoustic resonance at approximately 150 Hz within the turbine cover pressure relief pipe was indicated by the simulation results.

ramp. Amplitude spectrums were used to evaluate the local response of the system. In order to subsequently analyse the transmission behaviour, location and frequency-dependent colour charts were used in conclusion.

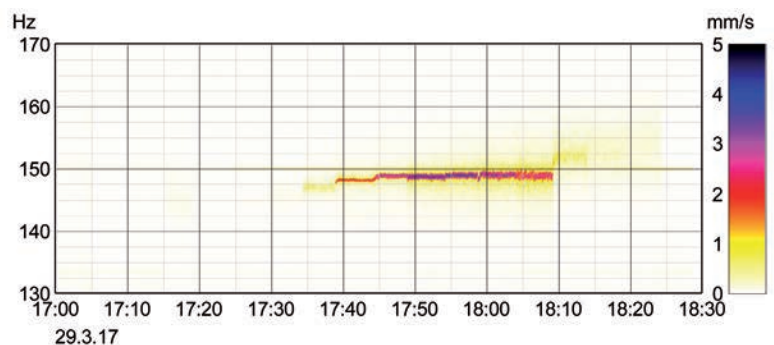
vibration showed that the vibration phenomenon only occurred in a very narrow-band range (see Figure 8). Furthermore, the vibration frequency at measuring point s13z appeared to remain at a fixed frequency of approximately 149 Hz here, even when the output was continuously increased via the volume flow. Such a latching is often explained by the involvement of structural-mechanical or acoustic resonance effects. An acoustic resonance in the hub cavity due to excitation by vortex shedding could therefore constitute a plausible mechanism causing the 150 Hz vibration phenomenon.

Fig. 8: Chronological sequence of amplitude spectrums for the vibration velocities on the turbine cover (s13z) as colour charts.

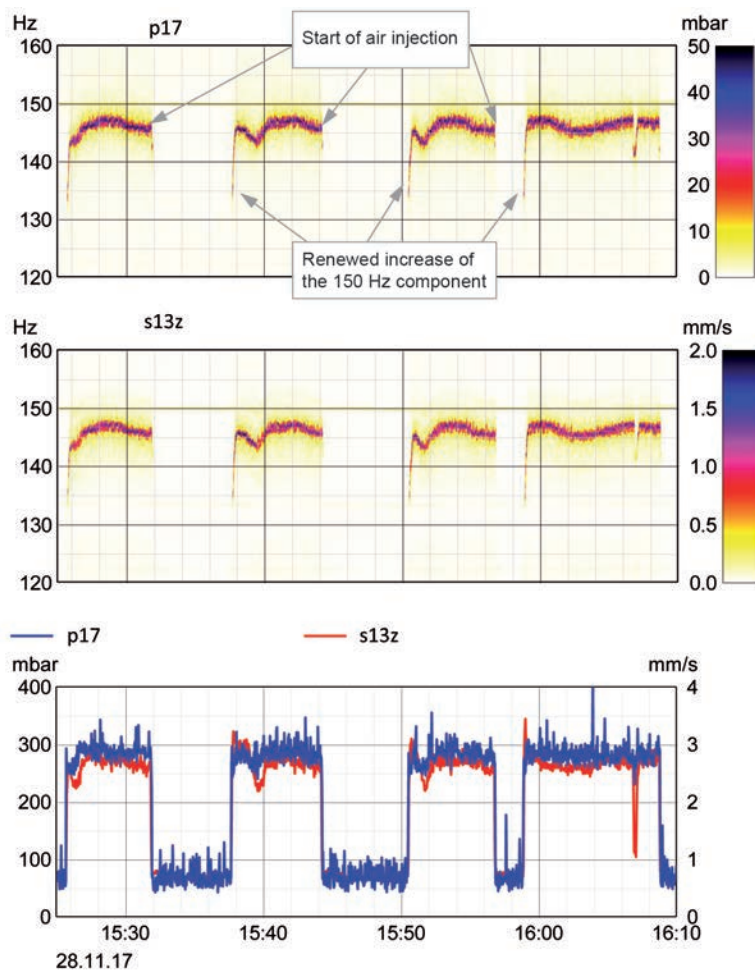
These tests were completed in a timely manner (also see Figure 9). The operating point with the 150 Hz vibration component was specifically chosen here. Then air was injected at various intervals for approximately 5 seconds at the original measuring point p27. The influence was visible in the pressure fluctuations, both in the intake pipe cone and on the turbine cover. The 150 Hz components abruptly disappeared at the time of air injection. Remaining, residual fluctuations and residual vibrations in the

The injection of air reduced the sound velocity of the water-air mixture from approximately 1,400 m/s for pure water to a fraction of this value. This drop was due to the ratio between the compressibility and density of a fluid that is relevant for the sound velocity. While the density remained approximately the same, the injected air considerably increased the compressibility of the medium. Thus, the medium is now easier to compress, resulting in a lower sound wave propagation velocity. This shifts the acoustic resonance frequency downward almost proportionally to the sound velocity so that dominant excitation is stopped.

After most of the air had been transported away, the compressibility decreased continuously. The sound velocity of the mixture changed again to the sound velocity of pure water. The sound velocity is highly dependent on the presence of air at a low per cent by volume (< 0.1 %). This dependency explains the very steep increase in the vibration frequency of the humming component from approximately 135 to 145 Hz. As previously mentioned, this increase is due to the dependency of the acous-

Fig. 9: Colour spectrums of measuring points p17 and s13z as well as the corresponding peak-to-peak curve for measuring point p17 and effective value curve for measuring point s13z.

tic resonance frequency on the sound velocity. When there was no more air in the area of the hub cavity, the vibration frequency once again stabilised slightly below 150 Hz.

A modification of the fluid properties – in particular the acoustic velocity – that could be implemented quickly was preferred over a geometric modification. Air injection tests – as close to the hub as possible – with a significant influence on the resonator were deemed suitable for implementation.
