# **Vibrations in the Environment - Remedial Actions at a New Compressor Foundation**

## **Field Investigation and Redesign by FEM-Calculations**

**9<sup>th</sup> Conference of the EFRC  
September 11<sup>th</sup> / 12<sup>th</sup>, 2014, Vienna**

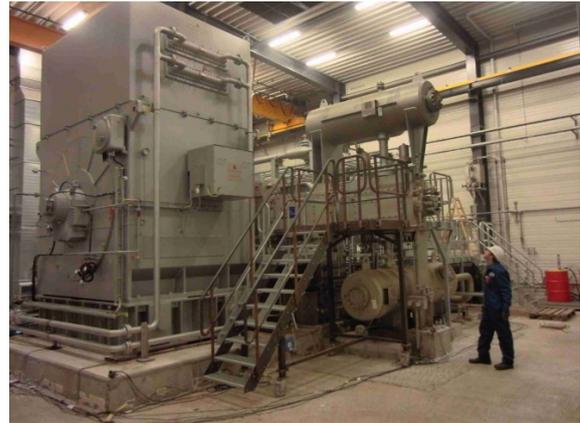
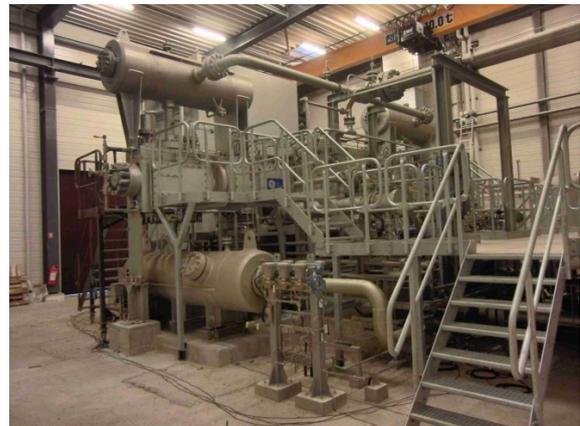
Figure 3: Compressor K-24 in the machine hall.

Thus, in order to detect the vibration behaviour in detail, extensive measurements during operation of the compressor were performed on site. Figure 3 shows the compressor K-24 inside the hall. The essential measuring positions at the concrete foundation are depicted in figure 4. During operation of the compressor the maximum vibration velocities arose at positions v02 and v05 in z-direction. These positions were located on the foundation area for the (vertical) supports of the compressor cylinders, see figure 5.

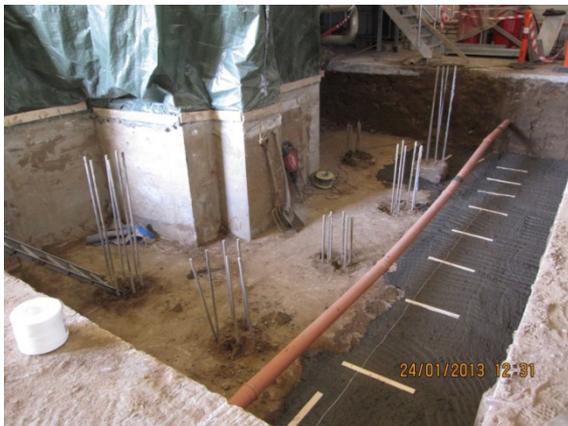
Figure 19: View on one side of the foundation after completion of the concrete piles.

Figure 19 shows the ends of the core wiring of the baskets which protrude from the pile heads for the monolithic connection with the extended slab (“wing”), see also figure 20.

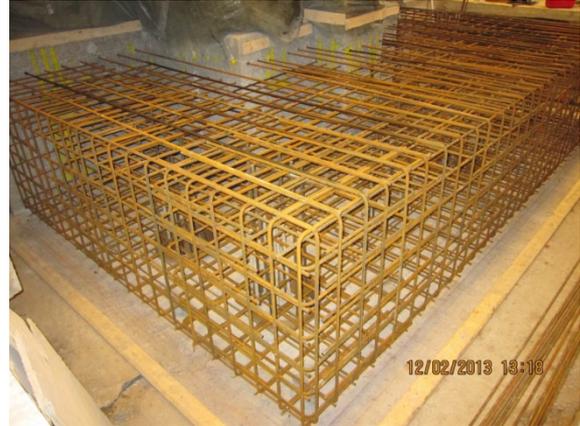
Figure 20: Reinforcement of the foundation extension.
