# **Vibrations in the Environment - Remedial Actions at a New Compressor Foundation**

## **Field Investigation and Redesign by FEM-Calculations**

**9<sup>th</sup> Conference of the EFRC  
September 11<sup>th</sup> / 12<sup>th</sup>, 2014, Vienna**

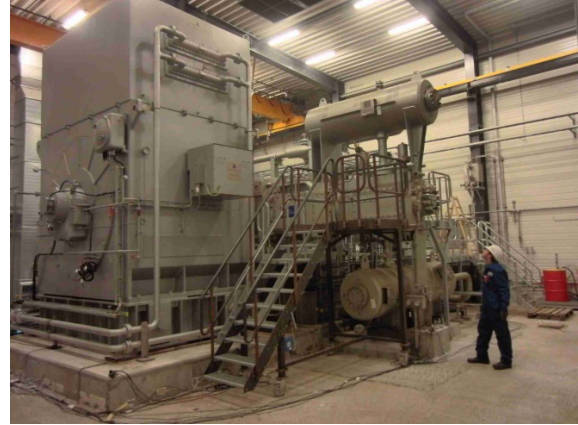
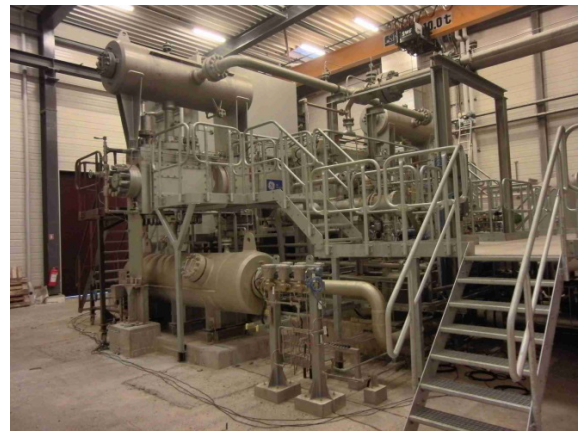
Figure 3: Compressor K-24 in the machine hall.

Thus, in order to detect the vibration behaviour in detail, extensive measurements during operation of the compressor were performed on site. Figure 3 shows the compressor K-24 inside the hall. The essential measuring positions at the concrete foundation are depicted in figure 4. During operation of the compressor the maximum vibration velocities arose at positions v02 and v05 in z-direction. These positions were located on the foundation area for the (vertical) supports of the compressor cylinders, see figure 5.

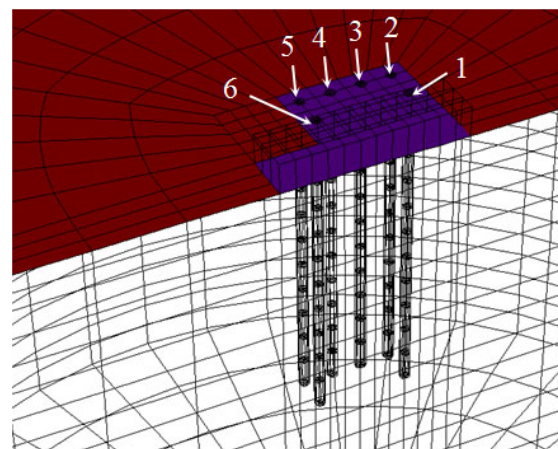
After discussion with the operator and the supporting civil engineering experts the final design for the extension of the foundation was configured with overall 12 piles, 6 piles below each slab, see figure 17.

Figure 17: FEM-model with numeration of piles for the final design of the foundation extension with 2 x 6 concrete piles.

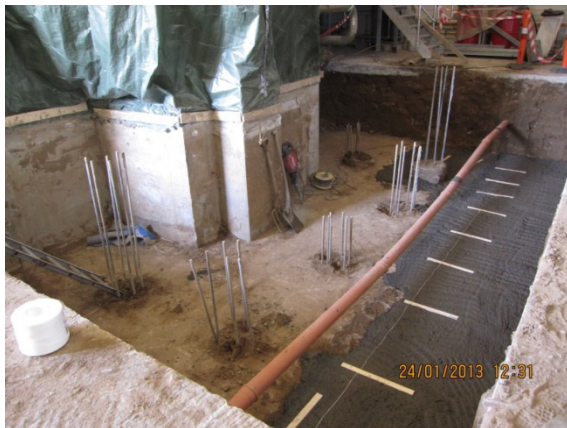
Figure 19: View on one side of the foundation after completion of the concrete piles.

Figure 19 shows the ends of the core wiring of the baskets which protrude from the pile heads for the monolithic connection with the extended slab (“wing”), see also figure 20.

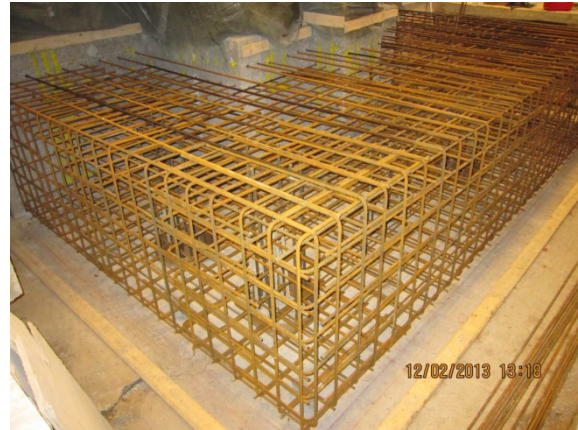
Figure 20: Reinforcement of the foundation extension.
