Successful vibration analysis on a 200 MW pump turbine in Luxembourg

Dr.-Ing. Patrick Tetenborg, Dr.-Ing. Johann Lenz, Dipl.-Ing. Gilles Nosbusch

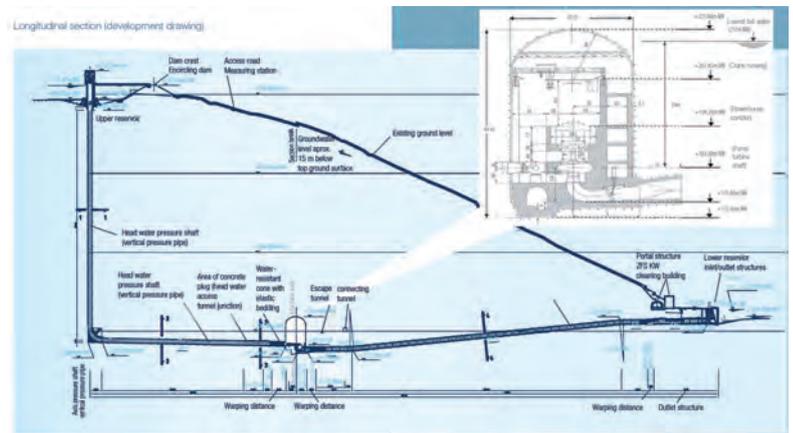
Fig. 2: Sectional drawing showing the arrangement of machine 11 with an enlargement of the underground cavern (source: SEO).

machine 11, an additional 200 MW pump turbine (see Figure 2). To inaugurate this system at the end of 2014, Joachim Gauck who was then the Federal President of Germany arrived in the course of a state visit to put machine 11 into operation together with the Grand Duke Henri of Luxembourg. The M11 is equipped with a Francis turbine (diameter 4.3 m), custom-made for pumping and turbine operation. It can be operated at a nominal flow rate of 78,200 l/s, turbine capacity of 197 MW and pump capacity of 196 MW.

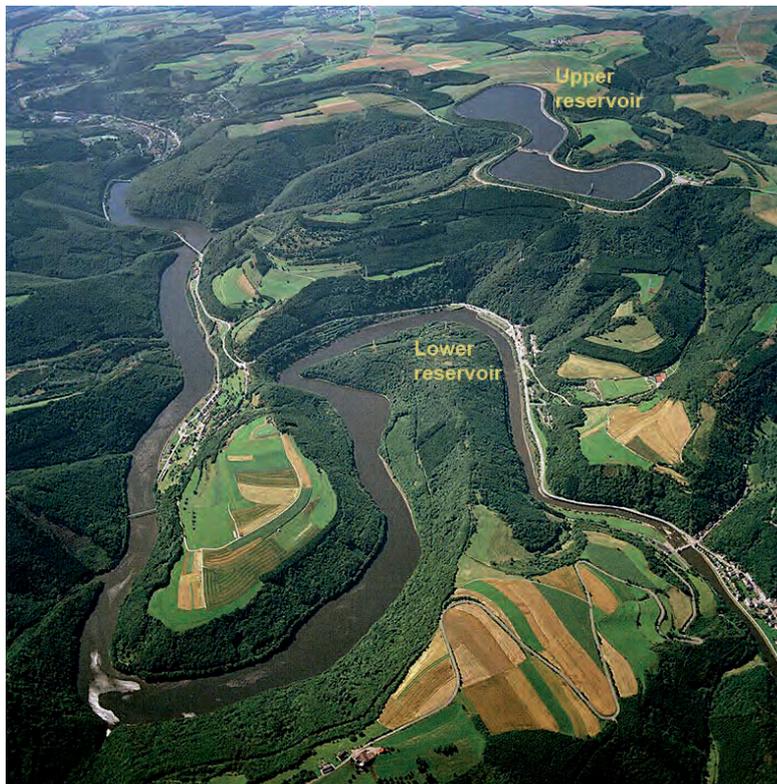
Fig. 1: Aerial photo of the separate upper and lower reservoirs along with the dammed course of the river (Our) in Vianden (Luxembourg).

The Vianden pumped-storage power plant in Luxembourg began operating at the end of the fifties and has since been expanded in various stages of construction. It is used to store excess energy – such as wind energy – and also to cover demand peaks. At times when consumption is low, for example at night, the excess energy from the base load power plants is used to pump water from the lower to the upper reservoir (storage). When the demand for electricity increases, the stored water flows through turbines back into the lower reservoir (see Figure 1).

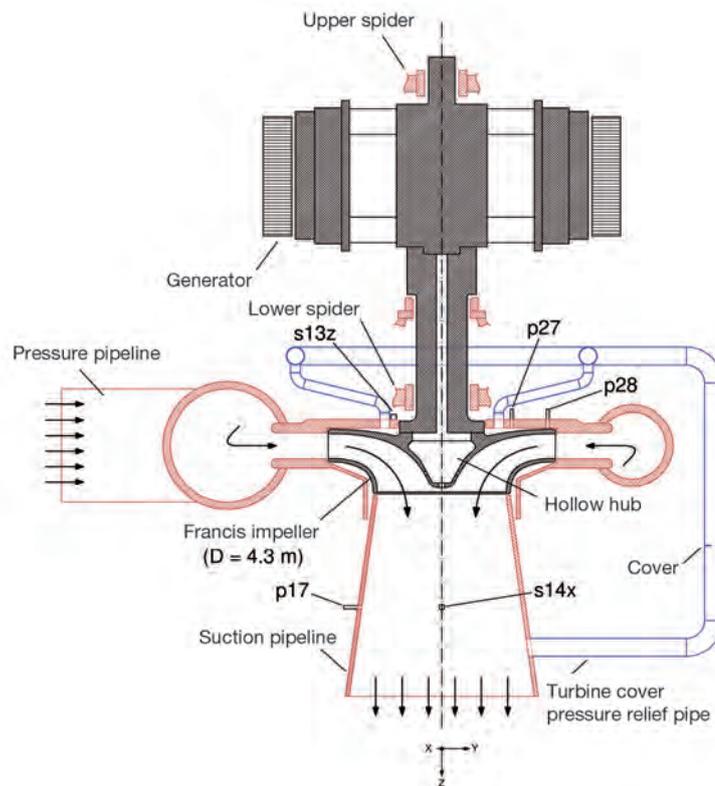
Fig. 3: Schematic diagram of the pump turbine structure with selected vibration measuring points (s13z, s14x) and pressure measuring points (p17, p27, p28).

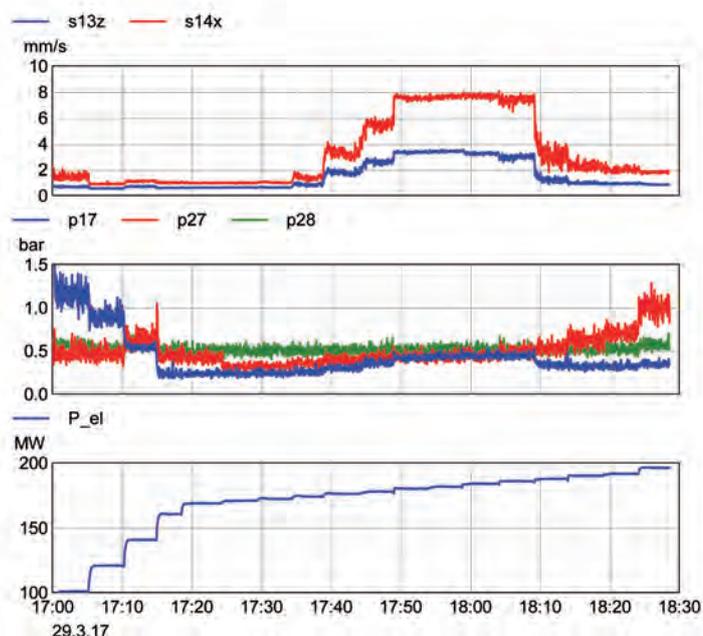
Fig. 4: Measured effective vibration speeds and peak-to-peak values on the intake pipe cone and turbine cover with corresponding output curve in turbine operation.

step over time. The effective vibration speed curves show an increase in the vibration level starting at approximately 174 MW, both on the turbine cover (s13z) and on the intake pipe cone (s14x). The maximum effective values are at approximately 180–184 MW. For the pressure fluctuations, the behaviour is not as clear. While the fluctuations on the intake pipe cone (p17) show tendencies similar to the vibration speeds, no correlation was initially detectable in the area of the turbine cover (p27 and p28). This is due among other things to the implementation of the pressure measuring points on the turbine cover. There is no way of venting them and their usefulness for the root cause analysis is generally limited.

Figure 4 presents an excerpt of the recorded vibrations as effective values and peak-to-peak values of the measured pressure fluctuations while changing the plant output step by

Thus, the phenomenon occurred both below (pressure fluctuations in the intake pipe cone and surface vibrations of the intake pipe cone) and above (vibrations of the turbine cover) the pump turbine. This finding as well as the investigations previously conducted by experts indicated an influence of the turbine cover pressure relief pipe. It connects the intake pipe to the upper lateral chamber of the impeller in order to ensure adequate axial thrust equalisation. Acoustic resonance effects constitute a possible influencing mechanism.

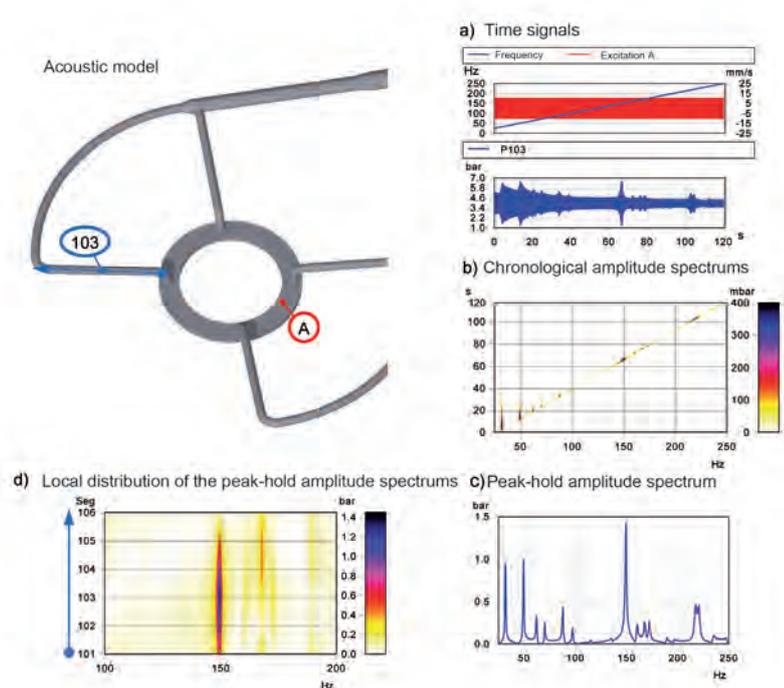
Fig. 5: Exemplary illustration of the calculation results: Pressure fluctuations at node 103 as time signal, as colour chart illustration with chronological amplitude spectrums, as peak-hold amplitude spectrum of the individual spectrums, and as local distribution of the peak-hold amplitude spectrum in a colour chart.

Figure 6 presents an excerpt of the modelled turbine cover pressure relief pipe and a one-dimensional illustration of the circular ring of the lateral impeller chamber. The investigated excitation positions and the positions of nodes relevant for the results are shown as well. A schematic of the evaluation is also presented. The simulations were performed in the time domain. The acoustic model was continuously excited using a frequency

In a first calculation step, the model was used to determine the acoustic transmission behaviour in the pipe as the actual situation. For this purpose, various exciter positions (here as an example: A) were used to induce pressure fluctuations in the lateral impeller chamber by specifying a frequency sweep of 25 to 250 Hz with a constant sound particle velocity amplitude. The system's acoustic transmission behaviour leads to different local distributions of the fluctuations depending on the excitation frequency and position.

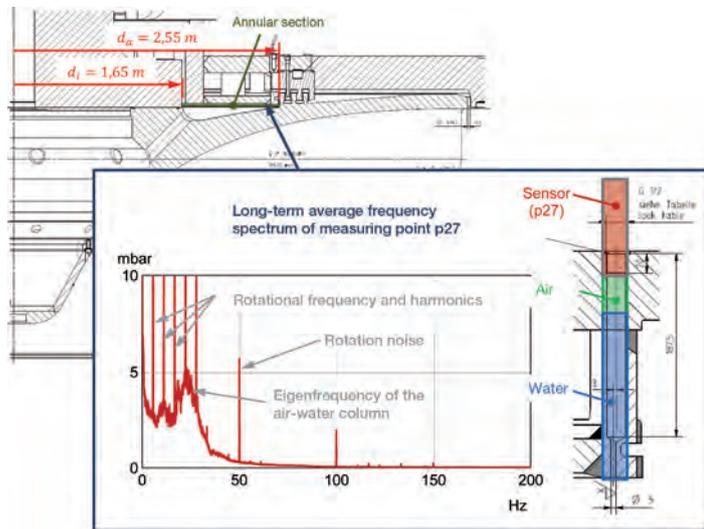
Fig. 6: Detail showing the location and implementation of measuring point p27 with a long-term average frequency spectrum at a turbine output of 160 MW.

For a qualitative determination of the transmission behaviour of the pressure fluctuations in the lateral impeller chambers at the measuring points, a noise band can be determined via long-term frequency spectrums (see Figure 6). In examining a noise band, it is assumed that all frequencies are stochastically excited by the turbulent flows so that a qualitative transmission behaviour can be determined. Averaging the spectrum at a very high resolution makes it possible to approximate the resonance frequency of the air-water column. This spectrum shows that high-frequency fluctuations in the area close to the hub of the lateral impeller chamber are only mar-

While the pressure signals had already been included in the recordings of the previous experts, they were not used further for the analysis due to the lack of venting. Figure 6 presents a detailed view showing the exact location and implementation of measuring point p27. The air in the connection bore cannot escape when the system is flooded. An air cushion therefore forms directly below the sensor head. This results in a system capable of vibration that, similar to a spring-mass system, is defined by the compressibility of the air (equivalent to stiffness) and the inertness of the water mass.

The area of the hub cavity and the annular space below the annular section at measuring point p27 (Figure 6, top) constitute an acoustic system similar to a Helmholtz resonator. In order to pragmatically assess the possibility of amplification occurring in this area, the eigenfrequency for an equidistant Helmholtz resonator was approximated. An initial assumption was made on the basis that the central hub cavity constitutes the volume and the discharge bores towards the flow channel constitute the inductive bottlenecks. The reso-

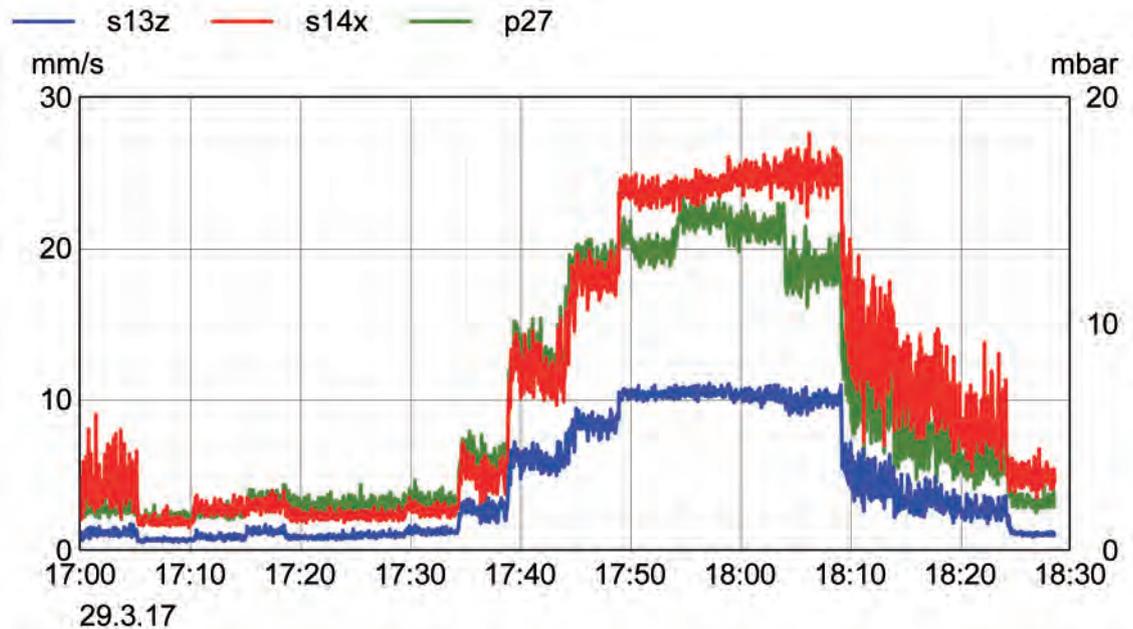
Fig. 7: Qualitative comparison of the bandpass-filtered peak-to-peak vibration velocities from 140 Hz to 160 Hz and the fluctuations at measuring points s13z, s14x and p27.

Based on this finding, the correlation of the pressure fluctuations at measuring point p27 were compared again to the vibrations on the turbine cover s13z and on the intake pipe s14z (see Figure 7). The curves show a very good quantitative correlation. The signals are proportional up to the vibration maximum and show slight devia-

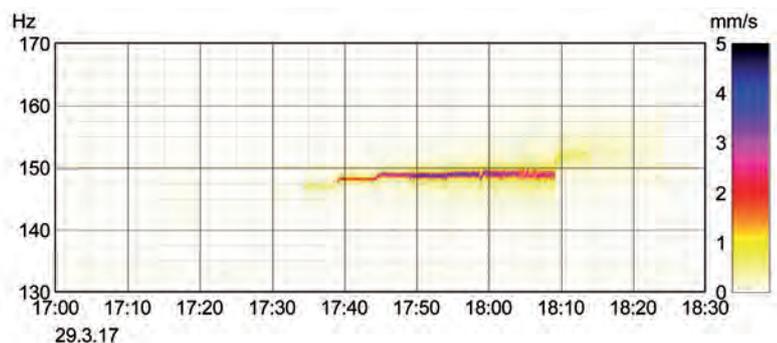
Fig. 8: Chronological sequence of amplitude spectrums for the vibration velocities on the turbine cover (s13z) as colour charts.

vibration showed that the vibration phenomenon only occurred in a very narrow-band range (see Figure 8). Furthermore, the vibration frequency at measuring point s13z appeared to remain at a fixed frequency of approximately 149 Hz here, even when the output was continuously increased via the volume flow. Such a latching is often explained by the involvement of structural-mechanical or acoustic resonance effects. An acoustic resonance in the hub cavity due to excitation by vortex shedding could therefore constitute a plausible mechanism causing the 150 Hz vibration phenomenon.

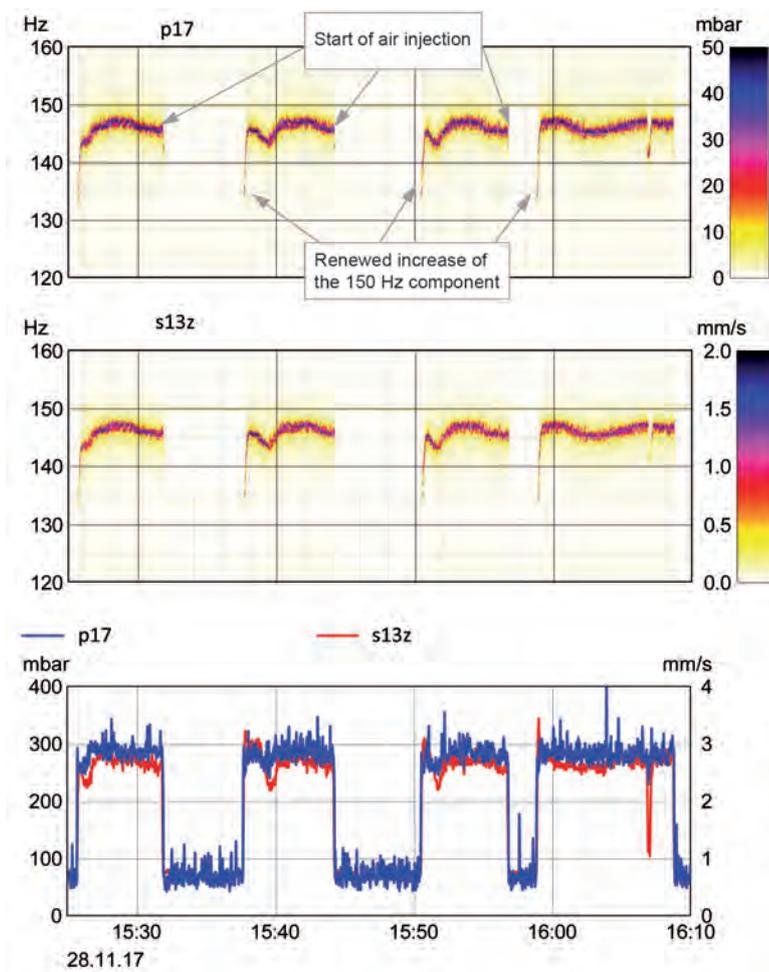
Fig. 9: Colour spectrums of measuring points p17 and s13z as well as the corresponding peak-to-peak curve for measuring point p17 and effective value curve for measuring point s13z.

These tests were completed in a timely manner (also see Figure 9). The operating point with the 150 Hz vibration component was specifically chosen here. Then air was injected at various intervals for approximately 5 seconds at the original measuring point p27. The influence was visible in the pressure fluctuations, both in the intake pipe cone and on the turbine cover. The 150 Hz components abruptly disappeared at the time of air injection. Remaining, residual fluctuations and residual vibrations in the

The injection of air reduced the sound velocity of the water-air mixture from approximately 1,400 m/s for pure water to a fraction of this value. This drop was due to the ratio between the compressibility and density of a fluid that is relevant for the sound velocity. While the density remained approximately the same, the injected air considerably increased the compressibility of the medium. Thus, the medium is now easier to compress, resulting in a lower sound wave propagation velocity. This shifts the acoustic resonance frequency downward almost proportionally to the sound velocity so that dominant excitation is stopped.

After most of the air had been transported away, the compressibility decreased continuously. The sound velocity of the mixture changed again to the sound velocity of pure water. The sound velocity is highly dependent on the presence of air at a low per cent by volume (< 0.1 %). This dependency explains the very steep increase in the vibration frequency of the humming component from approximately 135 to 145 Hz. As previously mentioned, this increase is due to the dependency of the acous-

tic resonance frequency on the sound velocity. When there was no more air in the area of the hub cavity, the vibration frequency once again stabilised slightly below 150 Hz.
