Vibration Instabilities on a Steam Turbine Generator Line

Depending on the resources available, gas as well as steam admission turbine plants are used for power conversion. During the start-up of such a generator line in Austria (Figure 1), considerably increased shaft vibrations were detected in the partial load range. As a result, the plant operator refused acceptance. The reason for the increase in vibrations was unknown, therefore, KÖTTER Consulting Engineers was commissioned to

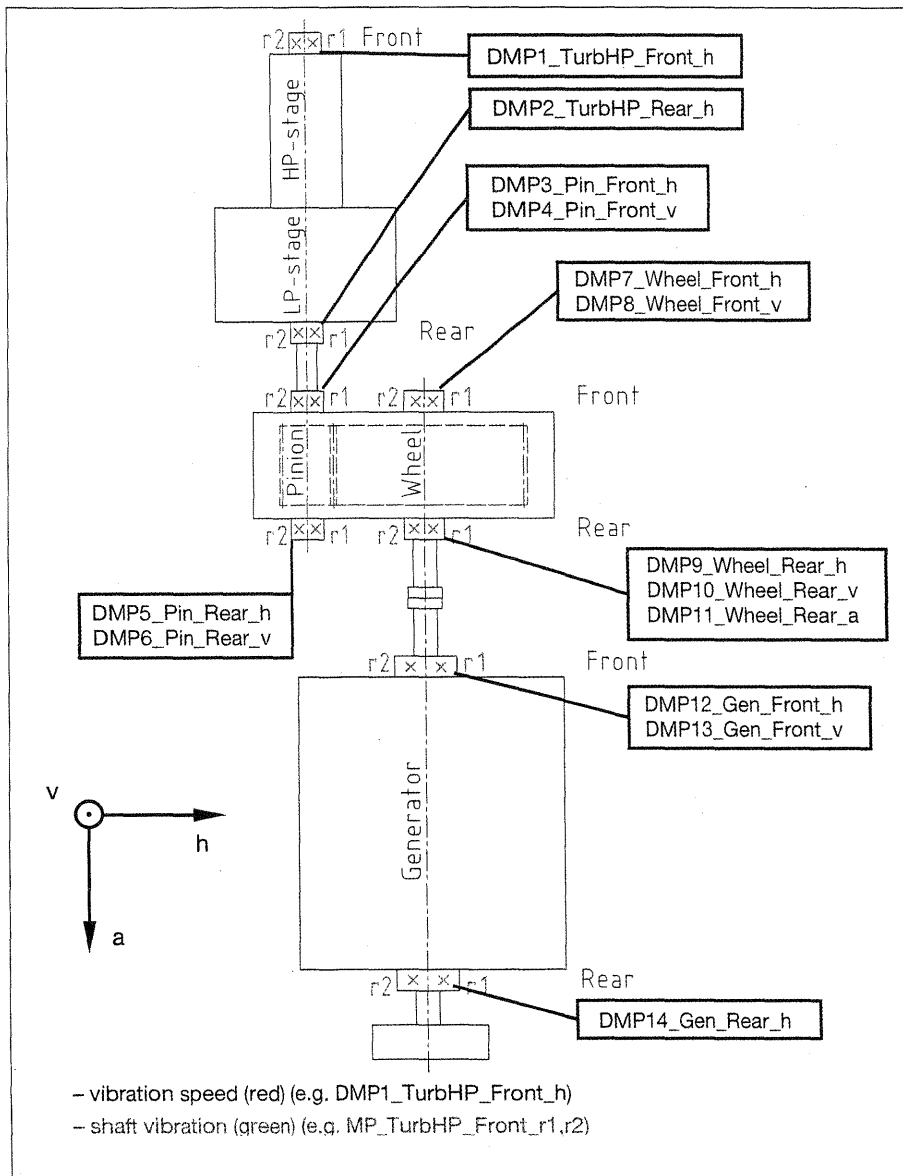
Figure 2. Principle sketch of the generator line as well as locations of the measuring points.

Figure 2 shows the principle arrangement of the generator line as well as the locations of the adopted measuring points. Proceeding from the steam turbine (rated output 8.5 MW) with a high-pressure part and a low-pressure part as well as a fixed operating speed of 12,065 1/min ($f_N = 201 \text{ Hz}$), the torque is transferred to the slow-running generator shaft with 1,500 1/min ($f_G = 25 \text{ Hz}$) by way of a single-stage gear with pinion and wheel shaft.

- Independent of the load range, increased bearing housing vibrations occurred locally confined at the outlet-side bearing of the low pressure part (DMP2_Turb-HP_Rear_h). The effective vibration speed of $v_{eff} = 7 \text{ mm/s}$ measured in the horizontal direction was primarily determined by a 25 Hz-component.

— In the partial load range (0.3 MW to 2 MW) increased bearing housing vibrations $v_{eff} = 5.2$ mm/s were detected at the gear and increased shaft vibrations were detected at the pinion shaft $S_{max} = 95$ μ m. The increased vibrations primarily occurred as single frequencies at approxi-

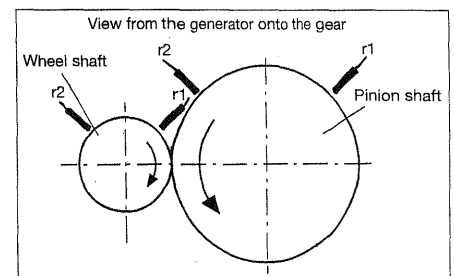
Figure 4. Position of the shaft vibration sensors r_1 and r_2 on the pinion and wheel shaft.

For the purpose of further analysis of the increased pinion shaft vibration in the partial load range, the orbit illustrations of the fast-running shaft line were compared for various loads. In order to serve orientation, the positions of the shaft vibration sensors (r_1, r_2) are shown in Figure 4 in an exemplary manner for pinion and wheel shaft.

- In the partial load range between 0.3 to 3.0 MW, increased shaft vibrations occur at the pinion shaft in particular.
- The frequency dominating the vibration lies at approximately 1/3 of the rotation frequency (sub-synchronous shaft vibrations, refer also to Table 1). The vibration frequency undergoes a minor change depending on the load condition.
- The direction of rotation of the increased sub-synchronous vibration is “concurrent” to the direction of rotation of the shaft.

A modification of the pinion shaft journal bearing system was recommended as a remedial measure for the purpose of avoiding instability. In this case, influence can be effected by way of an alteration of the bearing geometry (bearing type, width ratio, clearance) and also by way of the bearing loading and/or the viscosity of the lubricant. In addition to this, a stiffening of the low-pressure side bearing

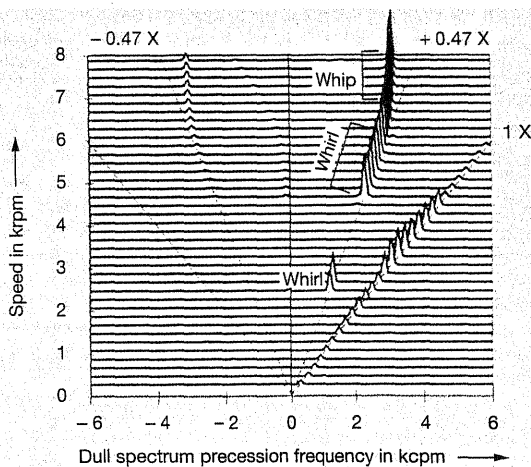
Figure 8. Two-side Campbell diagram with illustration of the oil-whirl and oil-whip phenomenon during the capacity-increase of a machine [1].

In the following Figure 8, these basic phenomena are shown in principle. The vibration amplitudes are plotted as a two-side Campbell diagram during the capacity-increase of a machine. As a diagonal traced, the single rotating frequency (+ 1 x) is shown as a dashed line and a further diagonal below the half rotating frequency (+ 0.47 x). On observing the single rotating frequency component during the recorded capacity-increase of the machine, the typical vibration camber occurs briefly when passing over the first natural frequency. If we compare to this the component of 0.47-times the speed, typically irregular vibration increases can be recognised (whirl) up to that time where the first natural frequency is reached here also. Increased vibrations then occur at this fixed frequency. This is also described as a “lock-in” (whip).

The decisive factor is that, as a rule, critical vibrations occur only when the oil-whirl-frequency and a natural frequency of the shaft coincide. In order to examine the location of the first bending natural frequency of the fast-running shaft, the capacity-increase of the turbine shaft in this case was recorded
