Coupling damage at a compressor of a LPG-tanker

MACHINE DYNAMICS

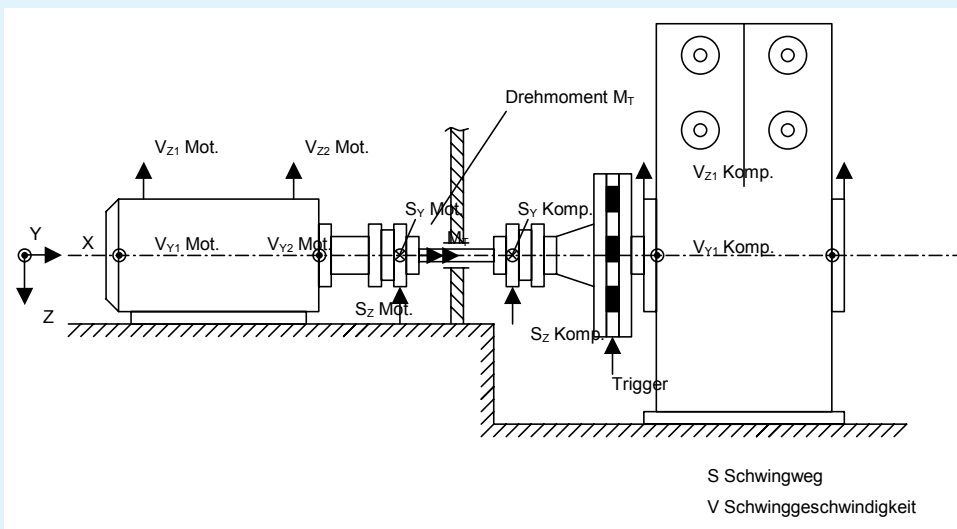
This vibration investigation at the compressors was carried out during a transit of the tanker from Houston, Texas via the Gulf of Mexico to Panama. Besides recording the absolute system vibrations and the rotor vibration, the investigation focused on the registration of the dynamical torque process in the drive train (figure 2). By using strain gauges on the drive unit and a signal transmission route via telemetry, the torque of the rotating drive shaft was measured during start-up and shut-down as well as during different load cycles in the operating compressor.

Overview of the measuring points
