MACHINE DYNAMICS

## Vibration reduction on cruise liners

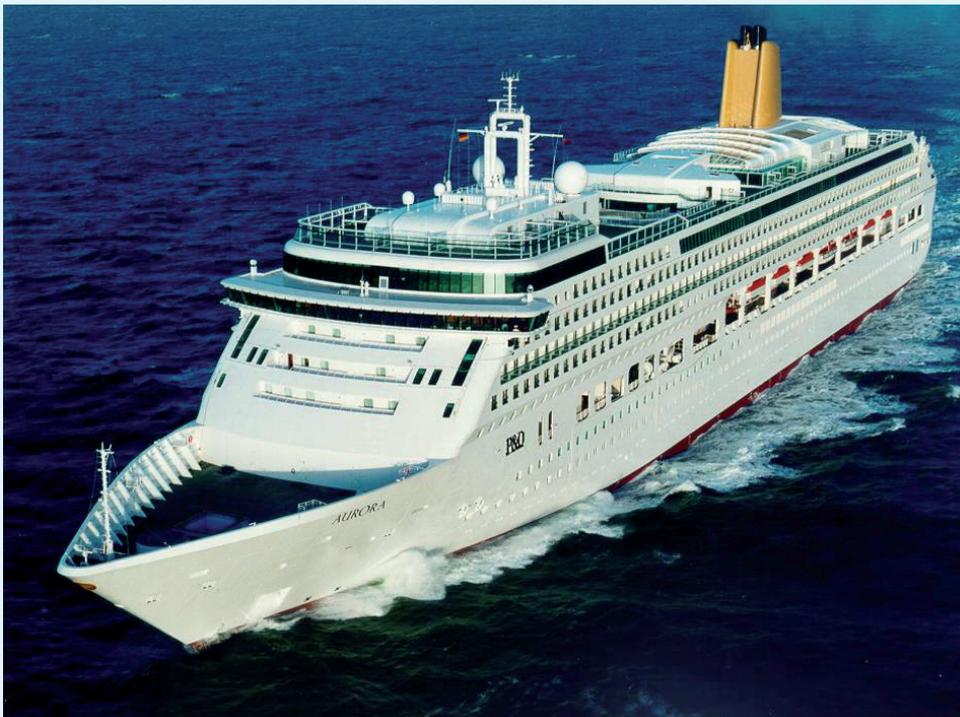
On a new cruise liner (figure 1) excessive vibrations occurred at one of the three electric motors/rotary pumps, all identical in construction. The vibrations were noticeable in a large area of the ship and exceeded the guideline values. Goal of the measurement carried out by KCE was to reveal the cause of the vibrations and to detect the mechanism responsible for this effect. Therefore, vibration velocity, rotational speed, and absolute pressure at the suction and discharge side of the pump were measured on two electric motors/rotary pumps. The following effect could be discovered:

View of cruise liner "Aurora"
