Dizzy vibrations at a briquette plant in Russia

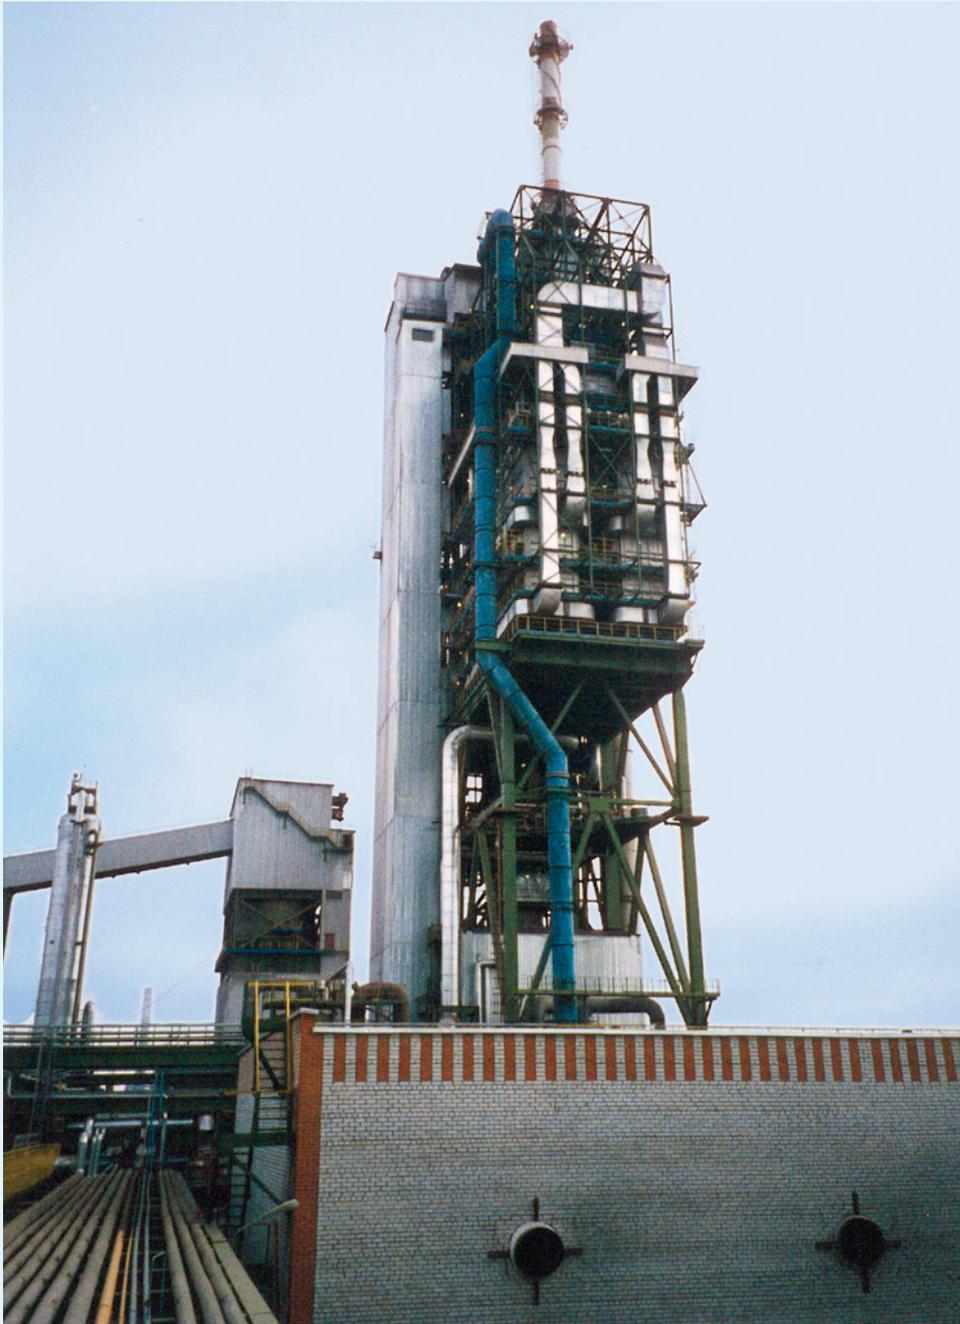
Overview of the briquette plant
