Trouble-Shooting in a Natural Gas Compressor Plant

Inadmissibly high vibrations had occurred in the main pipelines between the discharge-side pulsation damping of a newly installed natural-gas compressor. A duly conducted measurement analysis of the reason for these vibrations indicated that they were caused by strong pressure-pulsations in the cylinder rooms and in the downstream connection pieces to the pulsation damper vessels. A direct link between these pressure-pulsations and the mechanical vibrations was found in the region of the double-acting cylinders. Also the mechanical natural frequency of the connected pipe leads to inadmissible high amplitudes of vibrations.

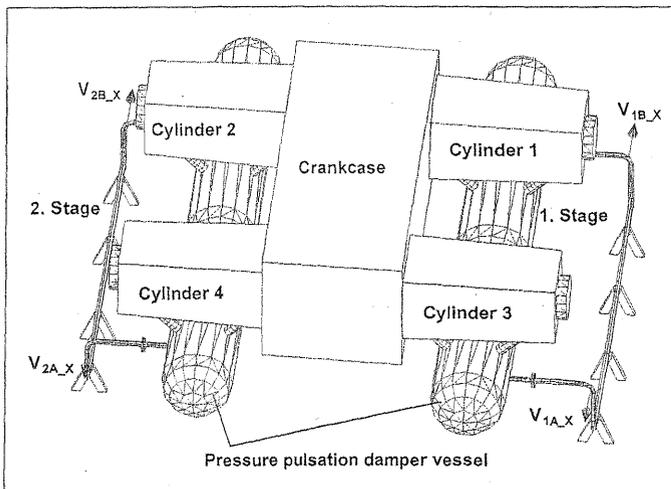
Fig. 1: Schematic diagram of reciprocating compressor, pressure pulsation damper vessels, connection lines, and the four points at which vibrations were measured

The first measurement of vibration rates made at the pipe bends in the modified version of the system shown in **Figure 1** exceeded the manufacturer's admissible standard levels several times over.

Furthermore, to make sure that the critical vibrations would no longer be excited by the pulsations still present in the connection pieces, the natural bending frequency of the pipe bends and pipe sections was displaced to a higher frequency (> 70 Hz) by means of an additional 'A' support, and broadband damping was incorporated. Because of the high temperature of the gas and the pipeline, a special means of connecting the support (**Figure 11**) was chosen for the region of the pipe bend (at the positions of the measurement points in **Figure 1**).

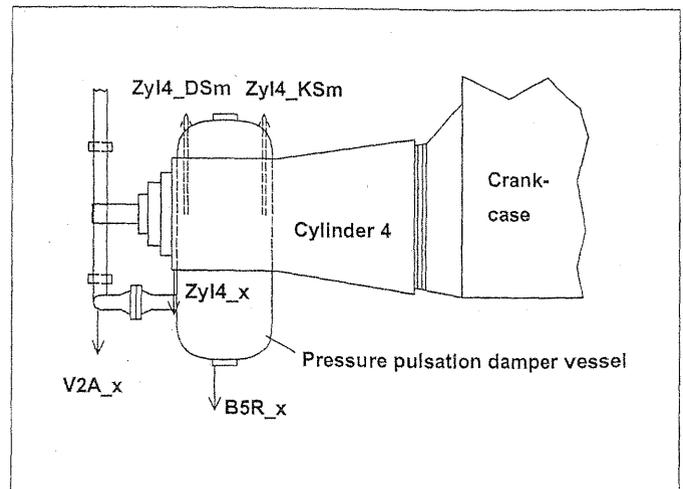
Fig. 2: Position of measurement points for detailed analysis of vibrations at Cylinder 4

Therefore at the same time, pressure pulsations and vibration rates at Cylinder No. 4, at the pressure-pulsation damper vessel connected to it and in the pipe bends were recorded selectively for further analysis (**Figure 2**).

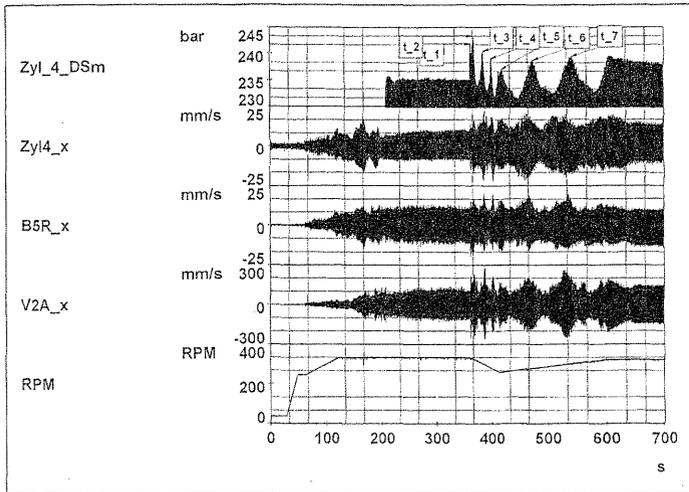
Figure 3 shows portions of the signals measured at Cylinder 4 when running up and when operating the compressor plant. The cylinder room (Zyl4_KSm) at the crankshaft end was shut off by controlled valve-suppression when this measurement was taken.

The chart shows the development of cylinder room pressure on the cover side, vibration rates at different measurement points, and rotational speed extending over a period of about 11 minutes from plant start-up. Especially at pipe bend $V_{2A,x}$, there is no recognisable increase in vibration at the measurement points when the plant is being run up ($t = 40 - 60$ s), so the likelihood of vibration being excited solely by the inertia force of the compressor can be ruled out. Once pressure has built up in the cylinder room ($t > 200$ s), however, continuously increased vibrations of about $V_{2A,x} = 100$

Fig. 3: Simultaneously recorded vibrations and pressure developments at Cylinder 4

mm/s become evident at the pipe-bend measurement point. The compressor is run at its rotational speed in the period $t > 360$ s (other operating conditions remaining constant), this being accompanied by a marked instance of short-time increases (t_1 to t_7) in cylinder-space pressure and in vibration rate at the measurement points shown.

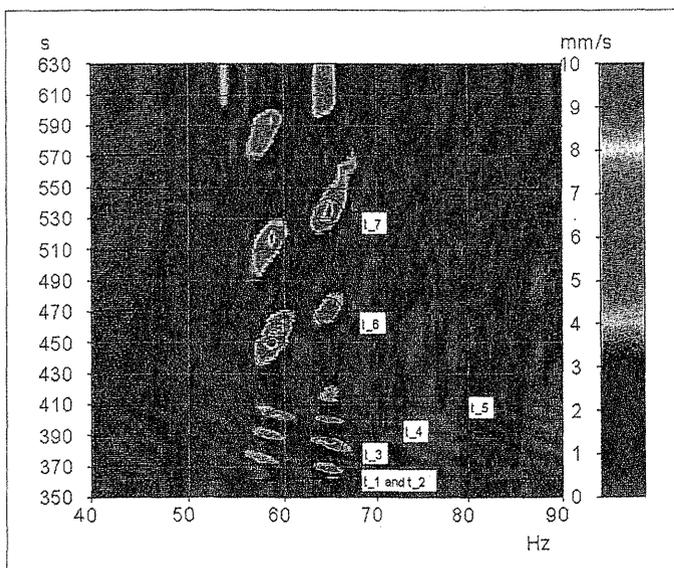
Colour charts of the amplitude spectra of the vibrations were produced to allow more precise examination of the relationship between the increased pressure fluctuations and the vibrations. To do this, the recorded time-signal was divided into small, overlapping time sections ($\Delta t = 1.6$ s), the amplitude spectrum (FFT) for each section then being duly calculated and represented as colour chart (amplitude level identified by colour) along the time axis. The colour chart in Figure 4 clearly shows that, at

Cylinder 4, two separate amplitude increases (58 Hz; 63 Hz) occur at different times along the x axis. Comparing the times of the maximum increases in cylinder room pressure in the function envelopes in Figure 3, the 63 Hz amplitude increase is the only one occurring at the same time in each case (Figure 4). While the order of magnitude of the vibration rates measured at the cylinder is not a cause for concern, those at the pipe bend (measurement point $V_{2A,x}$) are inadmissibly high, especially the 63 Hz recording (Figure 5).

Fig. 4: Colour chart of amplitude spectra for measurement-point Zyl4_x at the cylinder within the time range $t = 350$ to 630 s (time signal from Figure 3) cylinder 4

There is a striking increase in vibration between cylinder and pipe-bend (compare scale of Figure 4 and Figure 5).

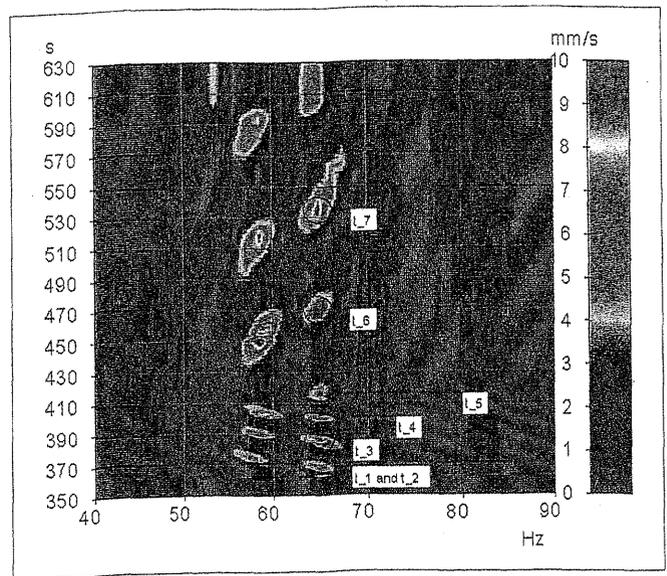
Fig. 5: Colour chart of amplitude spectra for measurement-point $V_{2A,x}$ at the pipe bend within the time range $t = 350$ - 630 s (time signal from Figure 3)

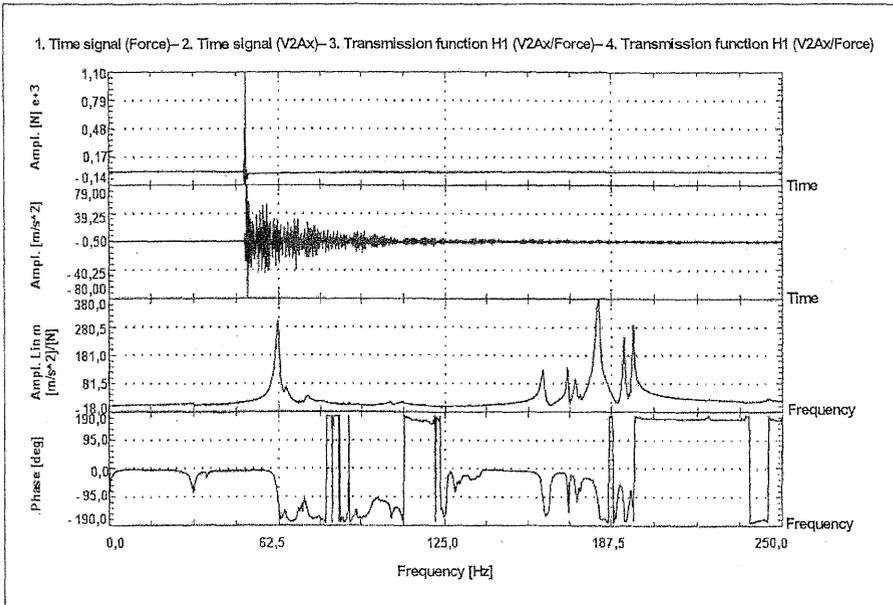
To arrive at an explanation of this increase in amplitude, the natural frequency of the pipe bend was analysed with the compressor plant at a standstill (Figure 6).

Excitation was produced by means of an impulse hammer at measurement-point $V_{2A,x}$, at which the acceleration response was also recorded along the x axis in each case. An amplitude increase occurs at about 62 Hz, accompanied by a 180° phase-shift between excitation and response signal. Accordingly, the increase in operational vibration between cylinder and pipe-bend is caused by a mechanical natural frequency, thus disclosing the transmission path of vibrations emanating from the cylinder. To ascertain the cause of the cylinder vibrations, the measured development in cylinder room pressure from Figure 3 at the maximum point ($t_2 = 368.2$ s) and at the succeeding minimum ($t_2^* = 375.6$ s) are plotted over time in Figure 4.

Fig. 6: Transfer function of acceleration signals of a force impulse excitation at the pipe-bend

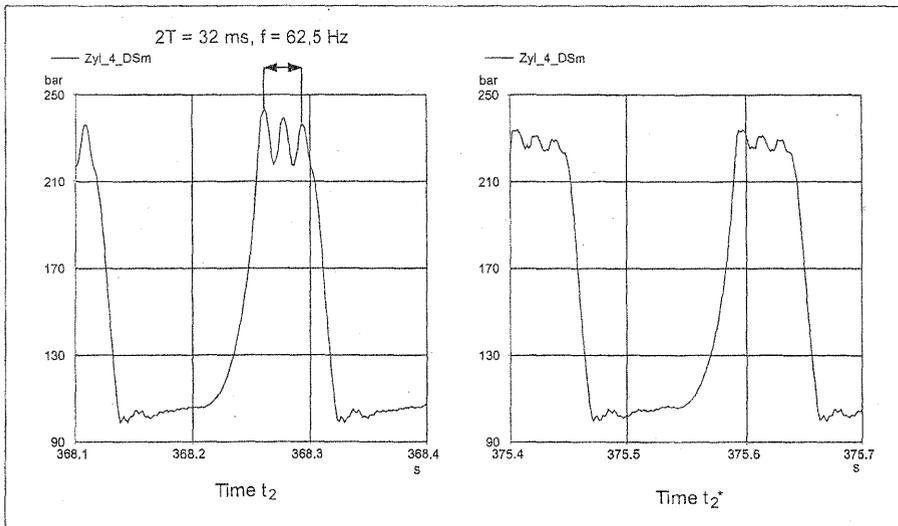
Pressure pulsations of up to 25 bar peak-to-peak (depending on rotational speed) occur at a frequency of $f = 62.5$ Hz in the process of exhausting the natural gas (Figure 7). These pulsations are the actual cause of the increased vibrations, which are transmitted mechanically from the cylinder, through the pulsation damper vessel, to the pipeline. The pulsation is excited by an acoustic natural frequency in the intermediate pipe (the connection between cylinder and pressure pulsation damper vessel) when it coincides with higher-harmonic frequencies of the rotational speed. The same effect was also found to exist in the other cylinders of the compressor.

Fig. 7: Measured pressure pulsations at 330 rpm (t_2) and 300 rpm (t_2^*)

It can clearly be seen that each time the pressure valve is opened (accompanied by the associated, abruptly beginning mass flow), a feebly dampened acoustic natural frequency is excited in the cylinder room and in the connection pipe. This acoustic resonance is responsible both for the increased strain on the drive unit and for the inadmissibly high pipe vibrations. The amplitude of the gas vibration is very decisively determined here by favourable or unfavourable coincidence between the opening of the valve and the phase angle of the acoustic resonance (see **Figure 7**).

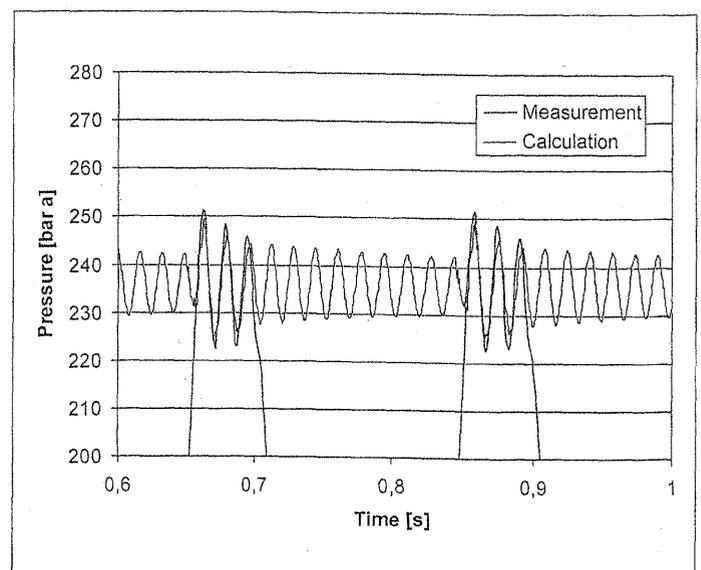
Fig. 8: Measured indicator diagram and calculated pressure inside the connecting pipe in original state

To begin with, the original system including its orifice plates was modelled for the purpose of validation. **Figure 8** illustrates the measured indicator diagram together with the calculated, time depending pressure at the discharge-side cylinder flange.

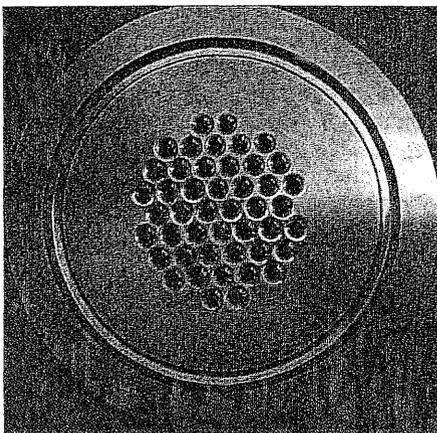
The pulsation damper plate (**Figure 9**) was then incorporated into the design model as the second stage of the simulation.

Fig. 9: Gas inlet side of patented "pulsation damper plate based on the KÖTTER principle" fitted to cylinder output flange of second stage

the plate), the pulsation damper plate offers a great many adjustment options. Apart from providing a choice of number of bore holes, hole pattern and bore-hole diameters, the venturi-like openings of this plate can be formed "at will", so the pulsation damper plate permits optimisation of acoustic or flow-conducting characteristics without additional loss of pressure.

The decision was therefore taken to replace the existing orifice plates fitted on the discharge-side cylinder flanges with patented "pulsation damper plates based on the KÖTTER principle". The unsteady, compressible, viscous compression and gas flow in the compression room and in the connection pipes was simulated numerically with a view to ensuring that the modifications would duly achieve their purpose. The simulation was based on the one-dimensional Navier-Stokes equation, the equation of continuity, the energy equation and the equation of state.

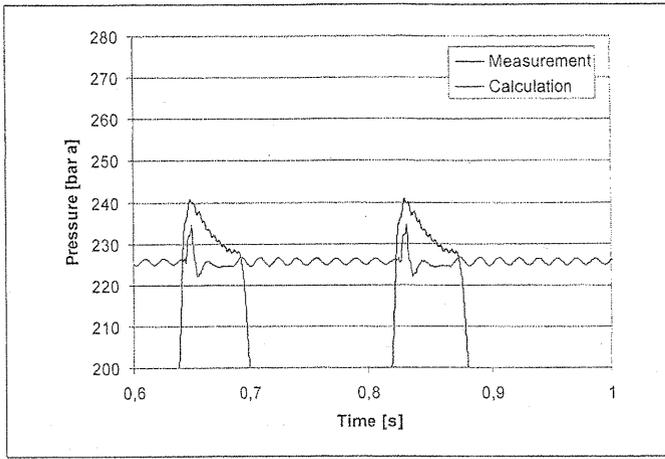
Figure 10 illustrates the outcome of this design process with the calculated time depending pressure at the discharge-side cylinder flange with pulsation damper plates installed. The measured indicator diagram after implementation of the modification is included in the figure for comparison purposes.

The theoretically ascertained satisfactory effect of the pulsation damper plates is confirmed by subsequent measurement. There are no more significant gas vibrations to be found in the indicator diagram either. The above-mentioned additional strain placed on the drive unit by alternating pressure loads on the piston has been eliminated by this means, and the alternating pressure amplitudes in the connection pieces have also been distinctly reduced.

Fig. 10: Measured indicator diagram and calculated pressure inside the connecting pipe with pulsation damper plate installed

However, it can still be seen that the measures adopted have only slightly increased the degree of acoustic damping provided when the pressure valve is closed. The reason for this is the predetermined installation position of the pulsation damper plate.

The only usable flange was located directly at the cylinder, which means that the pulsation damper plate is sited at the acoustically closed end when the pressure valve is closed.

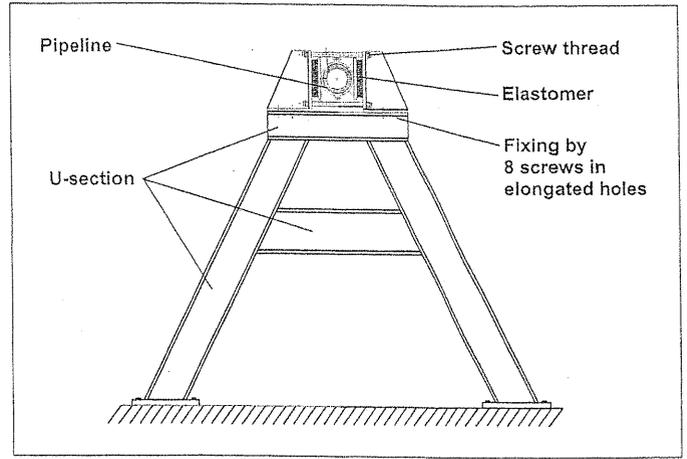
Fig. 11: Additional 'A' support as modification of pipeline section

The elastomer coating shown in Figure 11 is arranged without direct structure-borne noise bridges in such a way that the actual surface pressure of the elastomer (a decisive dynamic parameter) can be adjusted and optimised in situ by altering the tightening torque of the four bolts. Compared with conventional elastomer inserts, which are inserted directly between pipe and pipe clamp, the heat convection inherent in this design tolerates higher temperatures at the outside of the pipe.

Since the elastomer coating employed can only be used up to about 90 °C, the design in question was essential in the

present case to provide for additional dissipation of heat.

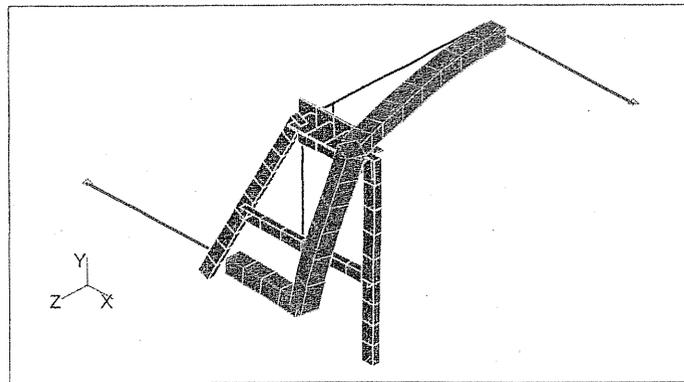
Fig. 12: FE model with 'A' support and elastomer, first natural bending frequency 79.4 Hz

A finite element calculation was performed in advance to optimise the dynamic characteristics of the intended pipe connection. The Finite Element model (FE) of the original pipeline section was adjusted with reference to the measured characteristic shape, thus making it possible to allow for the influence of the actual marginal conditions of the pipeline in a simplified FE model (bar model).

Figure 12 shows the calculated mode of the first bend in the pipeline with the optimised 'A' support and the elastomer

connection. Then the natural frequency is displaced upwards by 30 % as a result of this modification. The critical factor determining the position of the first natural bending frequency is the dynamic stiffness or rigidity of the elastomer.

Renewed measurement of the natural frequency of the first characteristic bending form or shape indicated a frequency of 83 Hz in the pipeline with 'A' support. In the light of the simplified FE model and the normal deviation of elastomer characteristics from manufacturer's specifications, this indicates good compatibility and confirms the validity of the procedure described above. The results of an additionally conducted measurement of operating vibrations at measurement-point V2Ax in the modified system are shown in Figure 13 for the purpose of comparison with the measured vibrations of the original system.

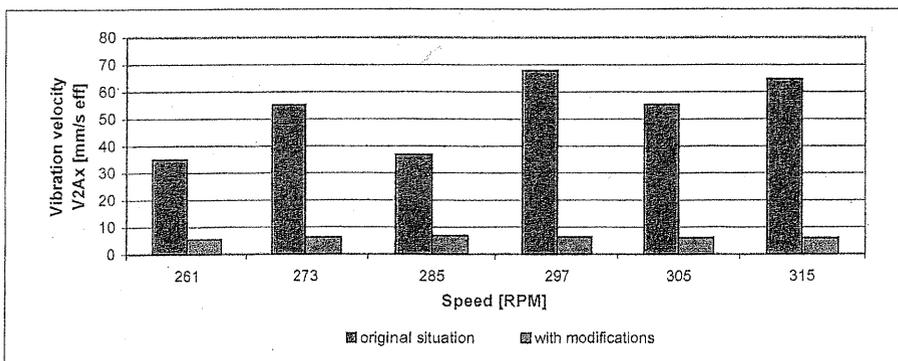
Comparison of the vibration situation before and after modifications impressively confirms the effectiveness of the measures adopted. A final examination of power loss attributable to the pulsation damper plates also demonstrated the precision employed in designing for pressure loss at the compressor output.

Fig. 13: Measured pipe-bend vibrations in original situation and with modification

In conclusion, the work of modification was followed by an examination of the measures implemented. To do this, the manufacturer arranged a detailed measurement of vibrations within the whole system at different operating points of the compressor plant, so as to rule out the possibility of any localised displacement of the pipeline vibration problem to other points. At an effective value of 15.5 mm/s, the maximum vibration rate measured in the process was well below the admissible standard value of 28 mm/s eff. The measurements also failed to disclose any relocation of the vibration problem.
